Sonoma and Carriger Creeks Alluvial Fan Assessment, Sonoma County, California

A Report for the Sonoma County Water Agency
and the
Southern Sonoma County Resource Conservation District

July 2012

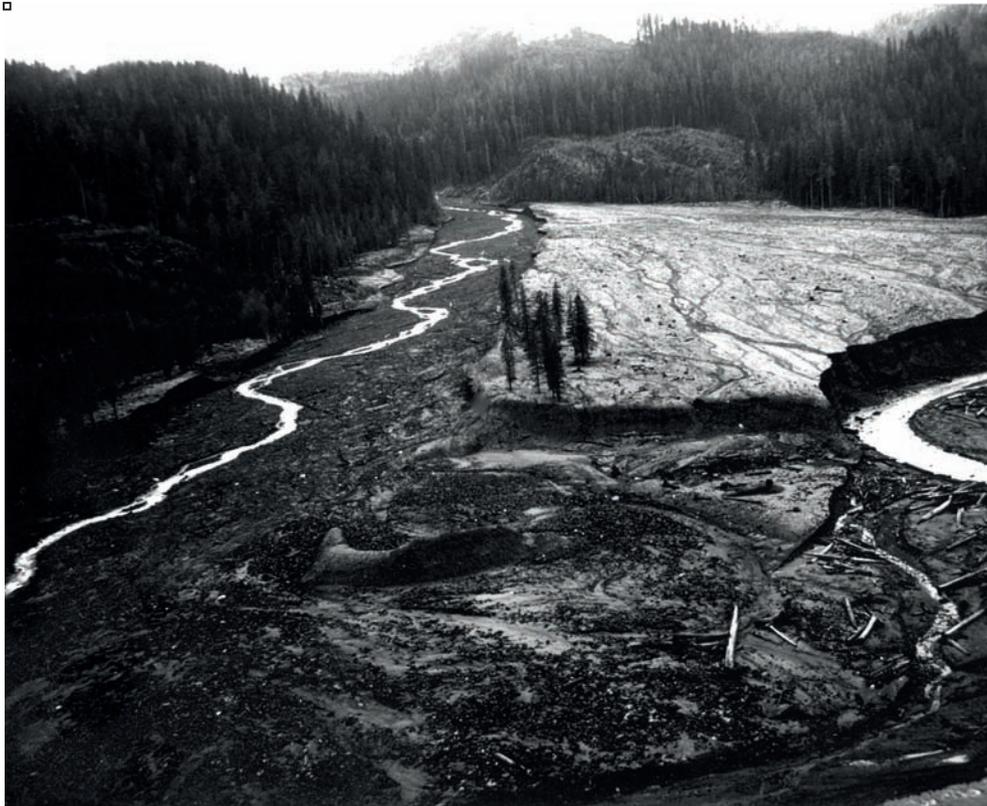
Figure 1. An example is shown of the alluvial fan at the confluence of Pine Creek with the larger Lewis Creek following the 1980 eruption of Mt. St. Helens in Washington. Notice the development of sinuous curvature in the larger straighter channel that developed after water and sediment was spread across the entire alluvial fan. Also note the many anastomosing overflow channels on the fan surface that has been building over thousands of years by punctuated catastrophic events. Photo by L. Collins, 1982.

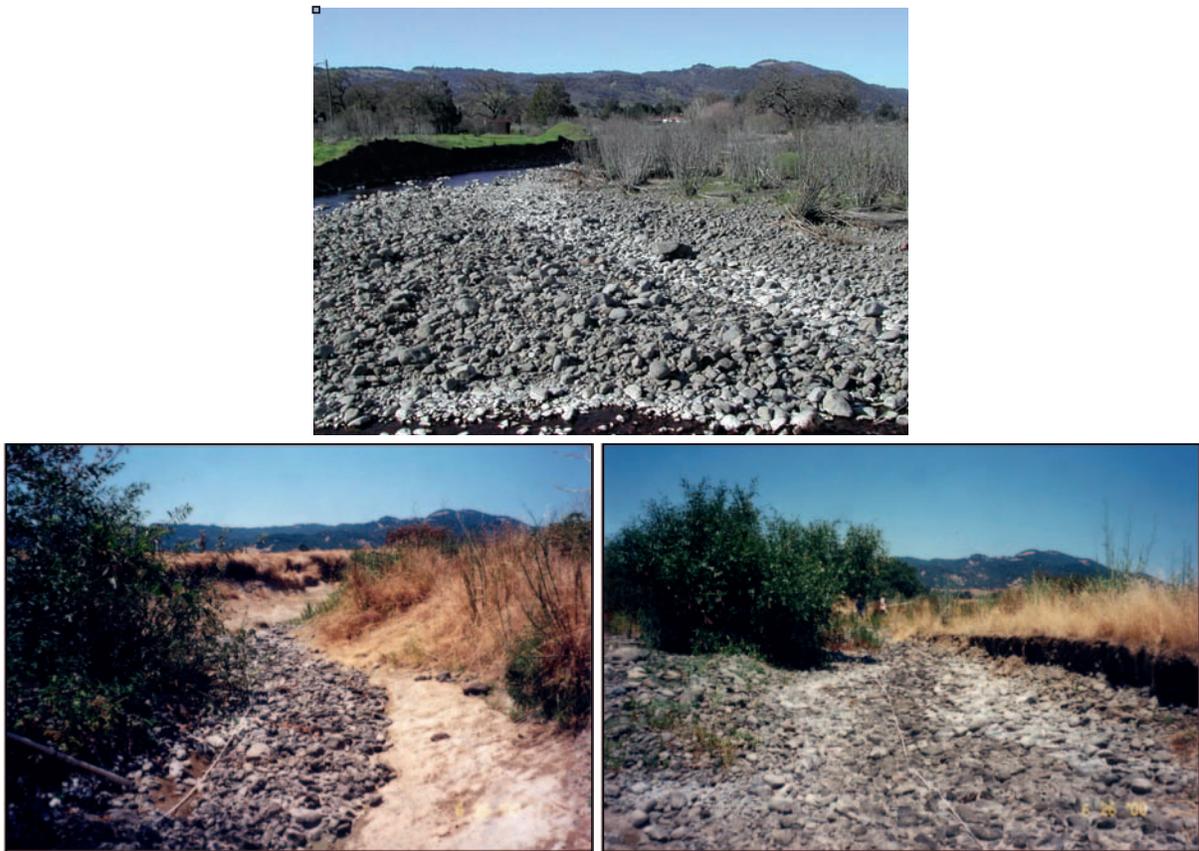
Figure 5. The top photo shows the coarse cobble bed of Carriger Creek, Feb 2012. The lower left photo shows the Quaternary Huichica clays exposed in a reach downstream of the upper photo along the lower Carriger Creek fan where small floods cause lateral migration into the clays and then incise the streambed that is not yet been armored by cobble transported by a large flood. The lower right photo shows the channel just downstream of the left photo that has not recently laterally migrated, incised, or abandoned its bed. Photos by L. Collins, June 2000.

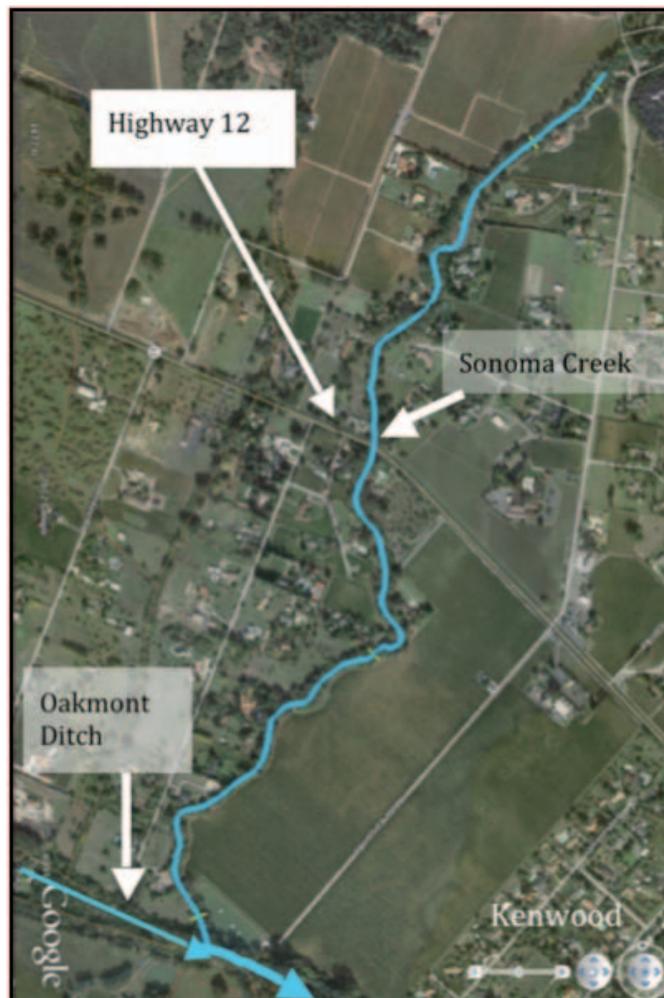
Figure 7. The mainstream reach of Sonoma Creek is shown along its alluvial fan.

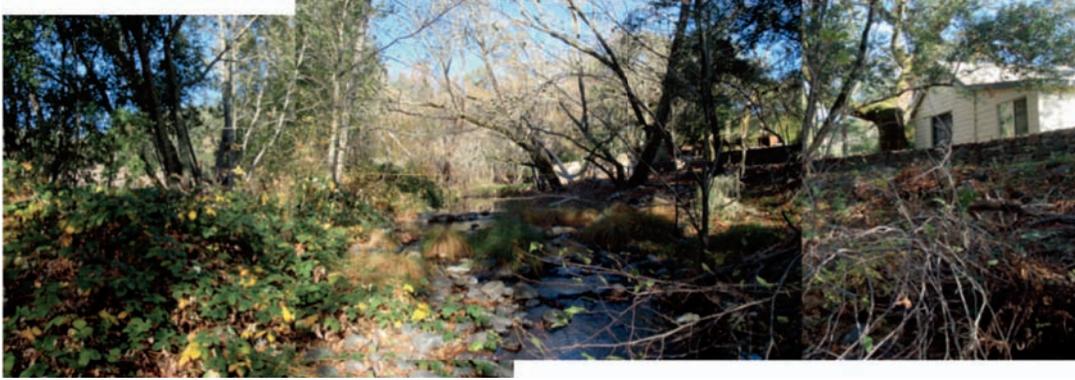
Figure 29. The upper 2011 Sonoma Creek Cross Section -2847 ft is shown looking upstream on the alluvial fan. Photos by L. Collins, Nov 2011.

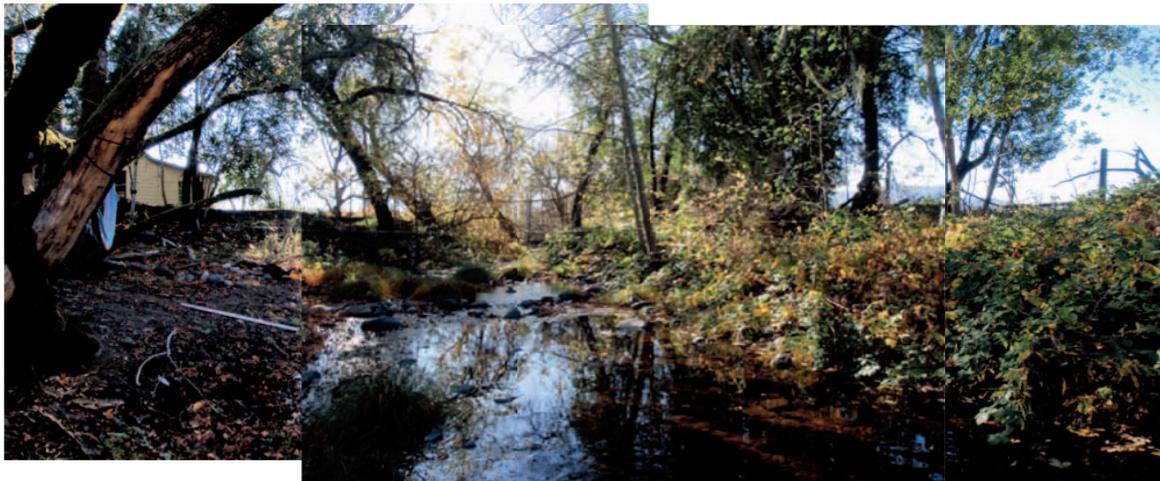
Figure 30. The upper 2011 Sonoma Creek Cross Section -2,847 ft is shown looking downstream on the alluvial fan. Photos by L. Collins, Nov 2011.

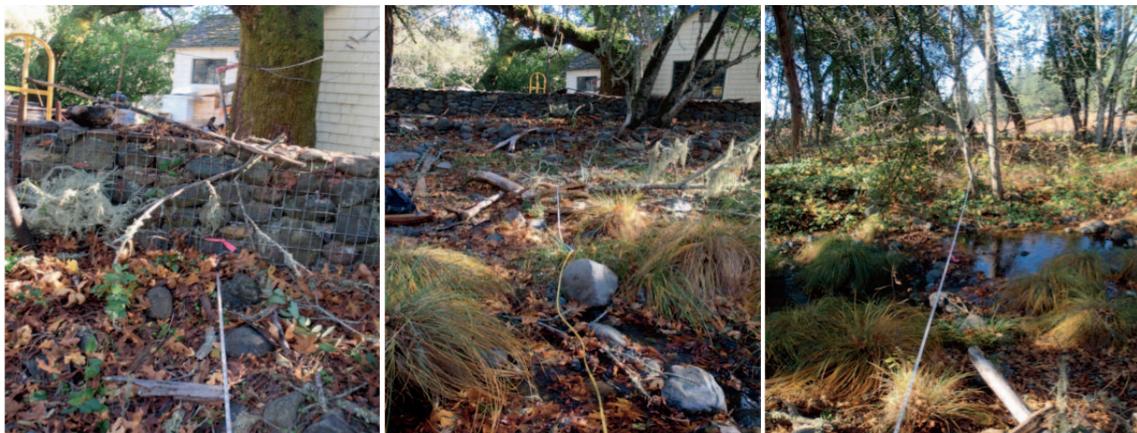
Figure 31. The left bank (left and middle photos) and right bank (right photo) are shown of the upper 2011 Sonoma Creek Cross Section -2,847 ft. Photos by L. Collins, Nov 2011.

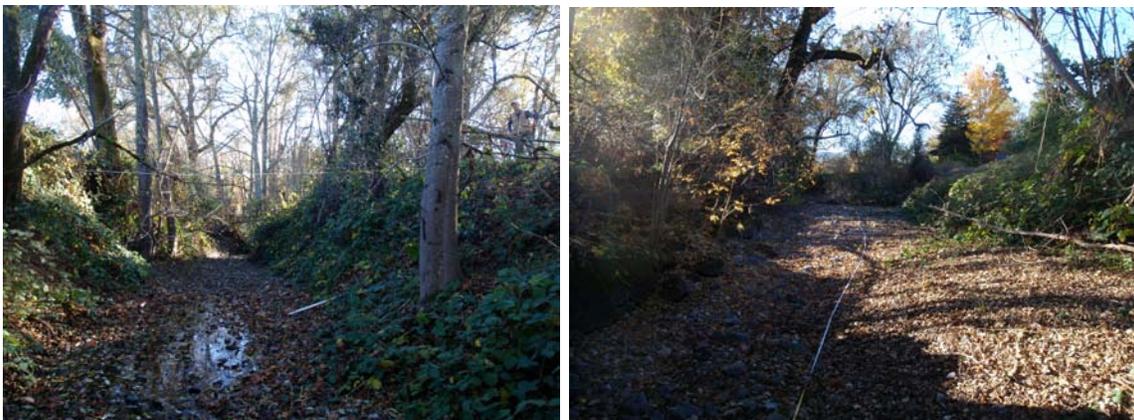
Figure 38. The lower 2011 Sonoma Creek Cross Section 3,937 ft is shown looking upstream in the photo on the left and looking downstream in the photo on the right. Photos by L. Collins Nov, 2011.

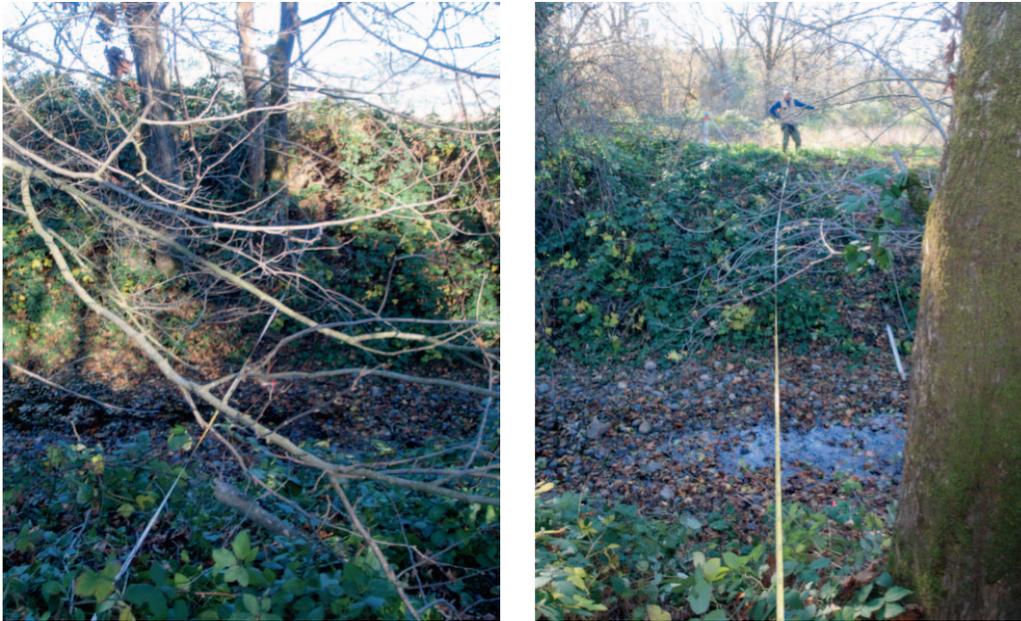
Figure 39. The lower 2011 Sonoma Creek Cross Section 3,937 ft is shown looking at the left bank (left photo) and the right bank (right photo) of on Sonoma Creek alluvial fan. Photos by L. Collins, Nov 2011.

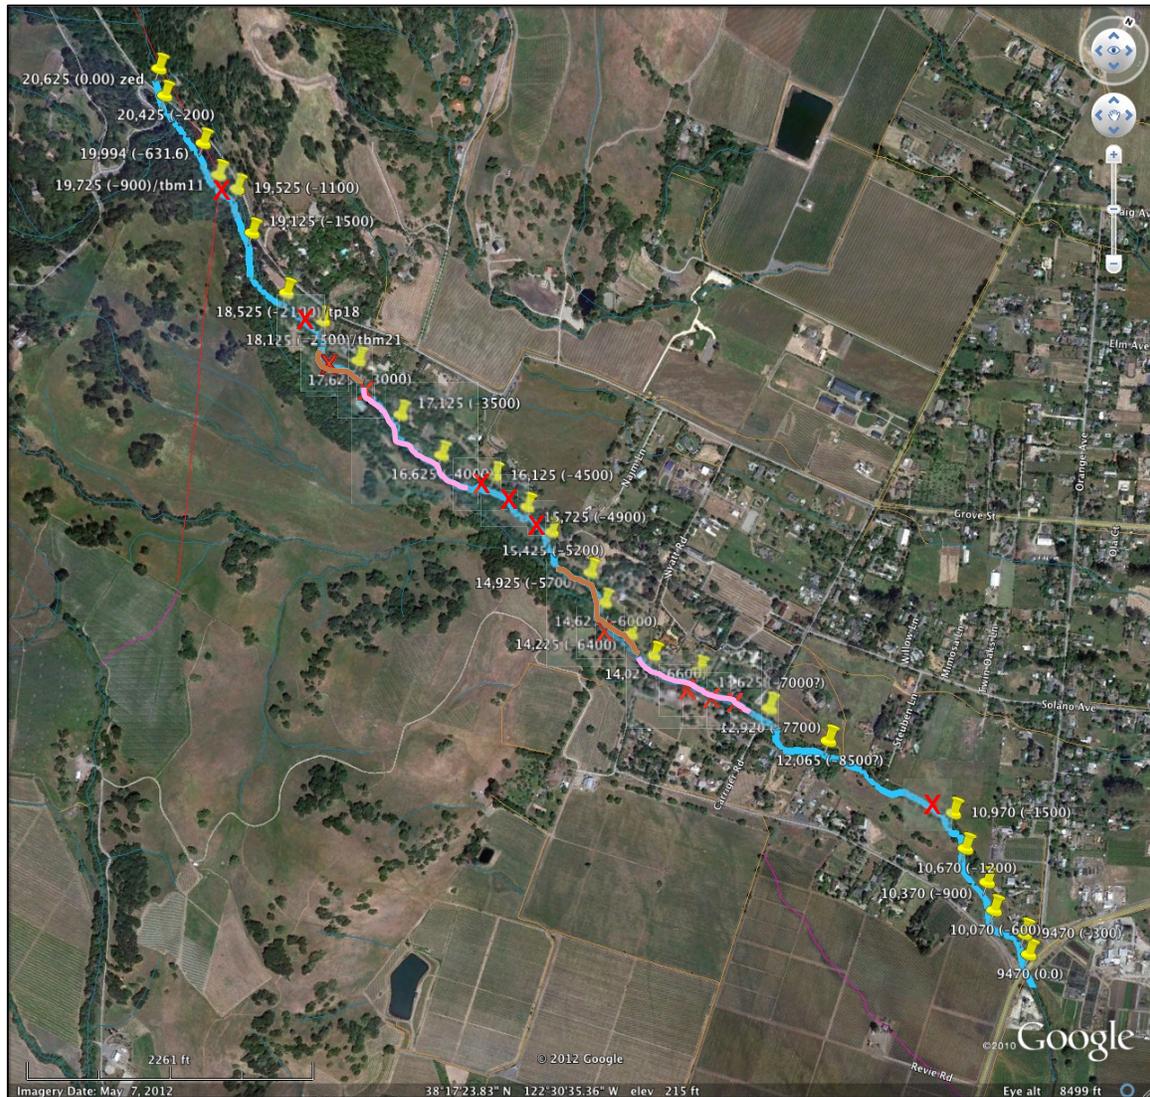
Figure 44. Estimates of distance station locations are shown at the yellow pinpoints along the mainstem Carriger Creek, which is shown as a thick blue line. The first sets of numbers are the distance stations in feet that are based upon zero being located at the confluence of Felder Creek. The numbers in parentheses are the stations established during the field survey with zero being located upstream of the Grove Street box culvert. As also indicated in Figure 45, the light brown lines represent the reaches that have had significant incision since WY 2006, while the light pink lines represent reaches with significant deposition. Several braided segments exist along the mainstem but they have not been mapped. The direction of flow is from top to bottom of the picture. Red X's represent approximate locations of inflection points where there are significant changes in stream gradient.

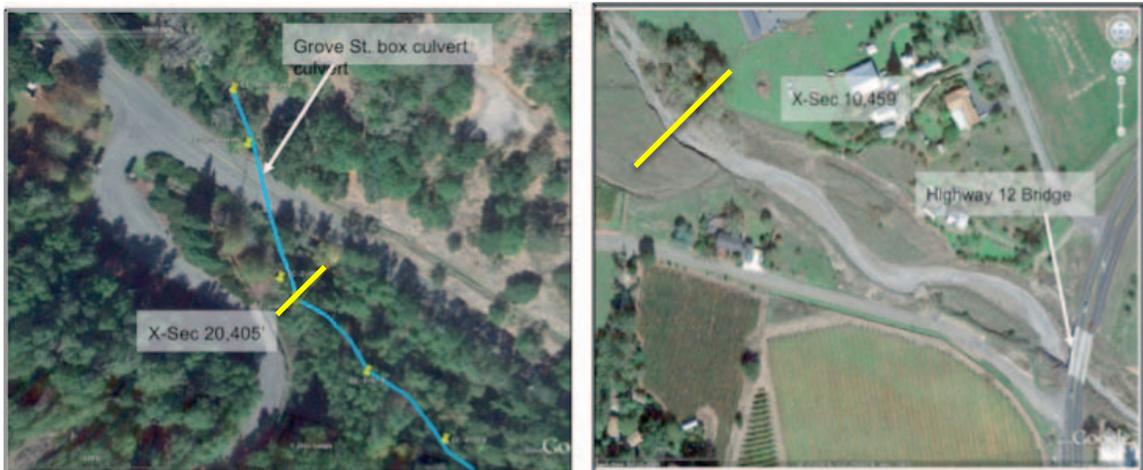
Figure 46. Details are shown of the location of the upstream Cross Section 20,405 ft in the photo on the left and the downstream Cross Section 10,459 ft in the photo on the right.

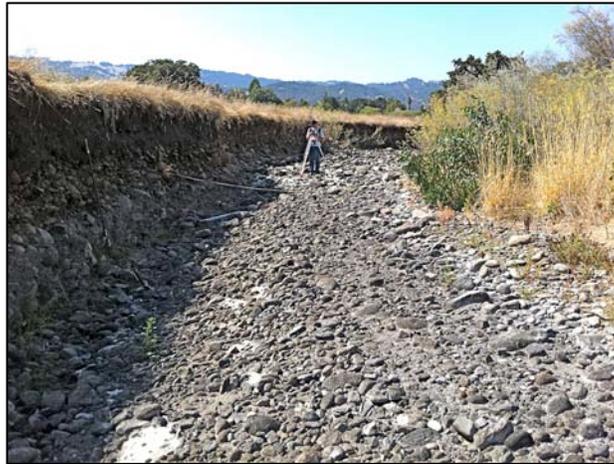
Figure 50. The lower Cross Section 10,459 ft is shown looking upstream at Carriger Creek alluvial fan. Photos by L. Collins, Sept 2011.

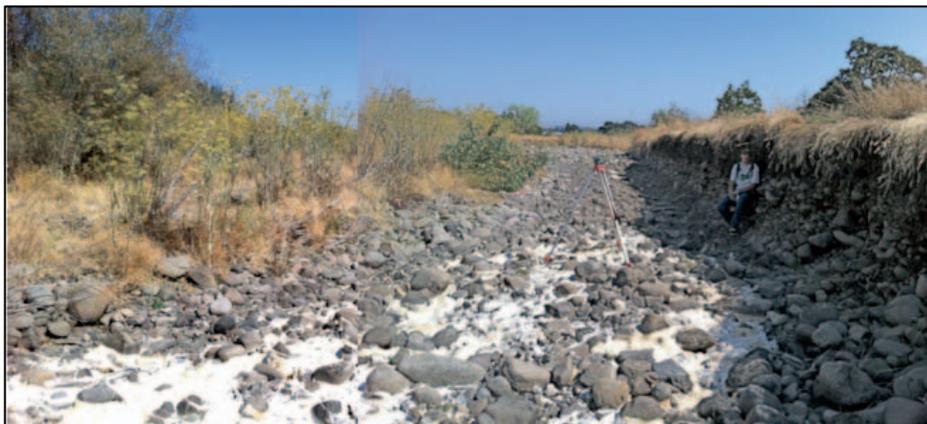
Figure 51. Lower Cross Section 10,459 ft is shown looking downstream at the Carriger Creek alluvial fan. Photos by L. Collins, Sept 2011.

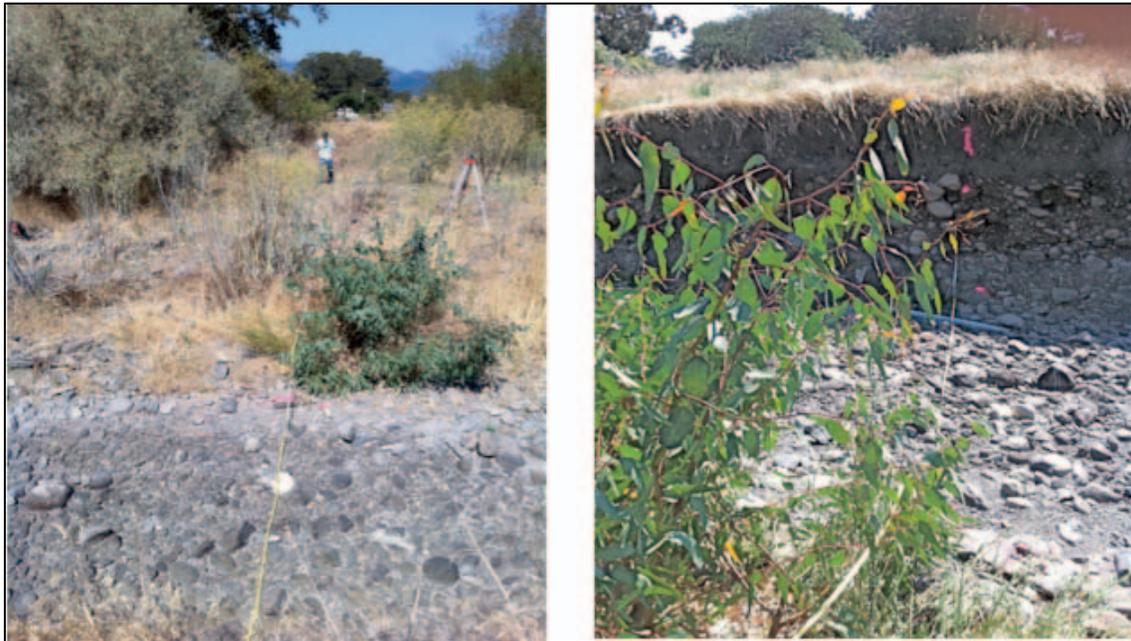
Figure 52. The Lower Cross Section Station 10,459 ft on Carriger Creek alluvial fan is shown looking at the left bank (photo on left), which has a mid-channel bar that is functioning as an inner floodprone bench, and at the right bank (photo on right), which has a higher terrace bank that is devoid of riparian vegetation. Photos by L. Collins, Sept 2011.

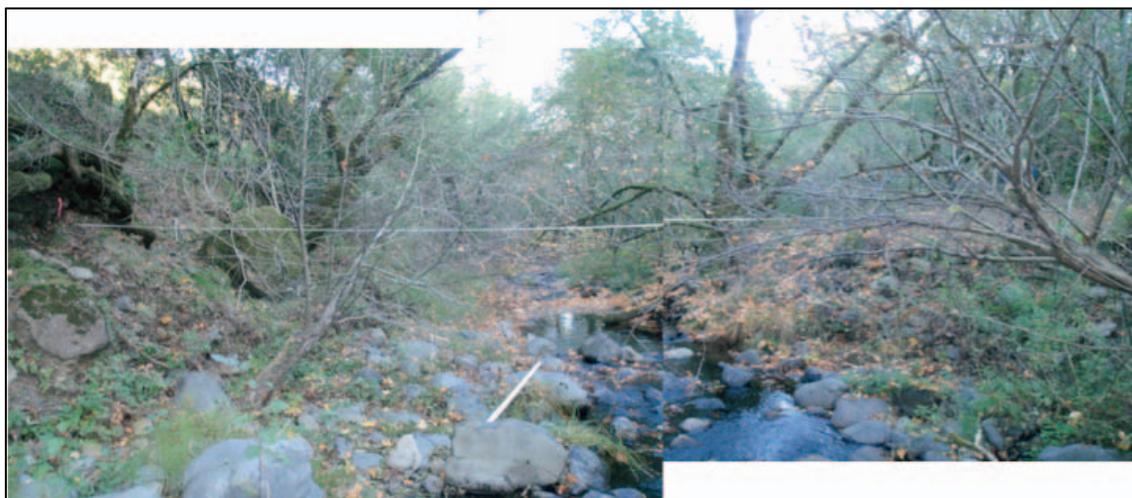
Figure 57. Station 20,405 ft on the Carriger Creek alluvial fan is shown looking downstream at the Upper Cross Section. Notice the 10-ft-high terrace on the right bank. It indicates long-term incision at the site. Photo by L. Collins Dec 2011.

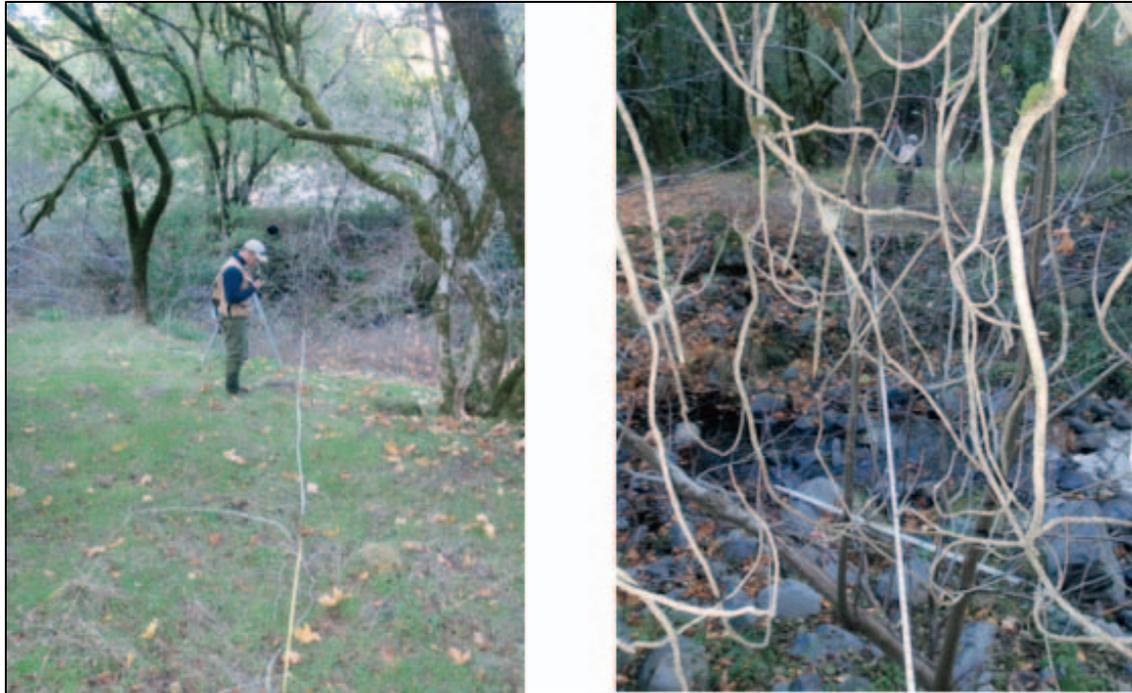
Figure 58. The Upper Cross Section at Station 20,405 ft on the Carriger Creek alluvial fan is shown looking at the high terrace on the right bank (photo on left) and looking at the right bank from the left bank (photo on right). Photos by L. Collins, Dec 2011.
