AUSTIN CREEK WATERSHED ASSESSMENT

Austin Creek Watershed.

October 2005

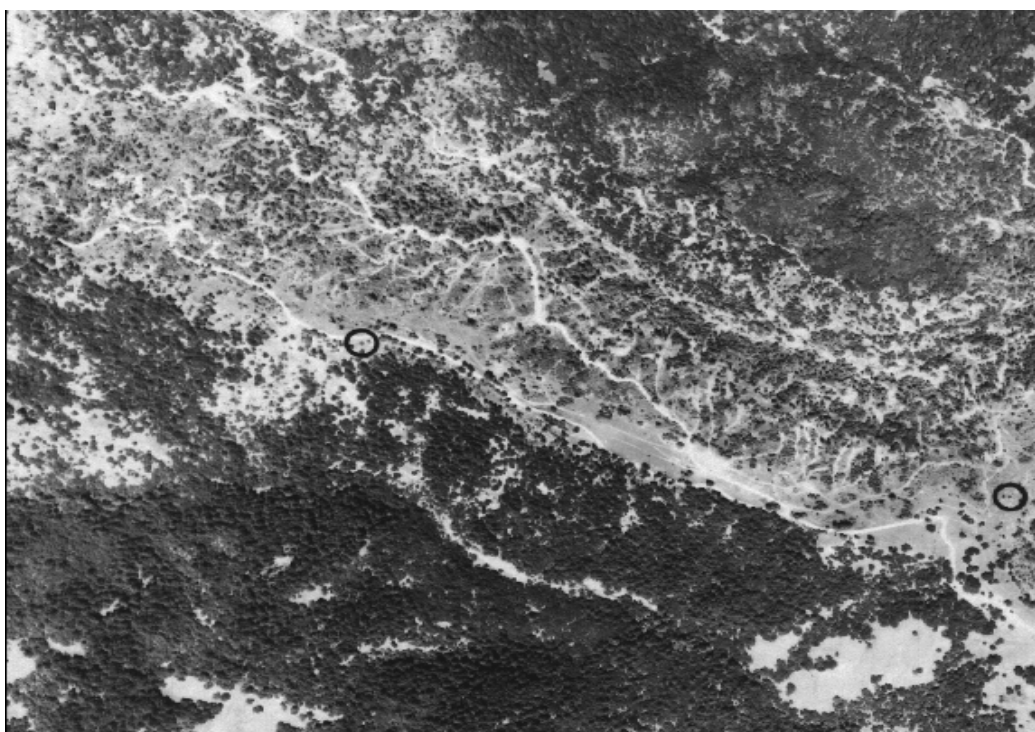
Figure 2. Top: 1941/42 aerial showing cleared conifer forest in Lower Austin Creek Sub-basin Bottom: 2000 aerial showing regrown conifer forest at same location

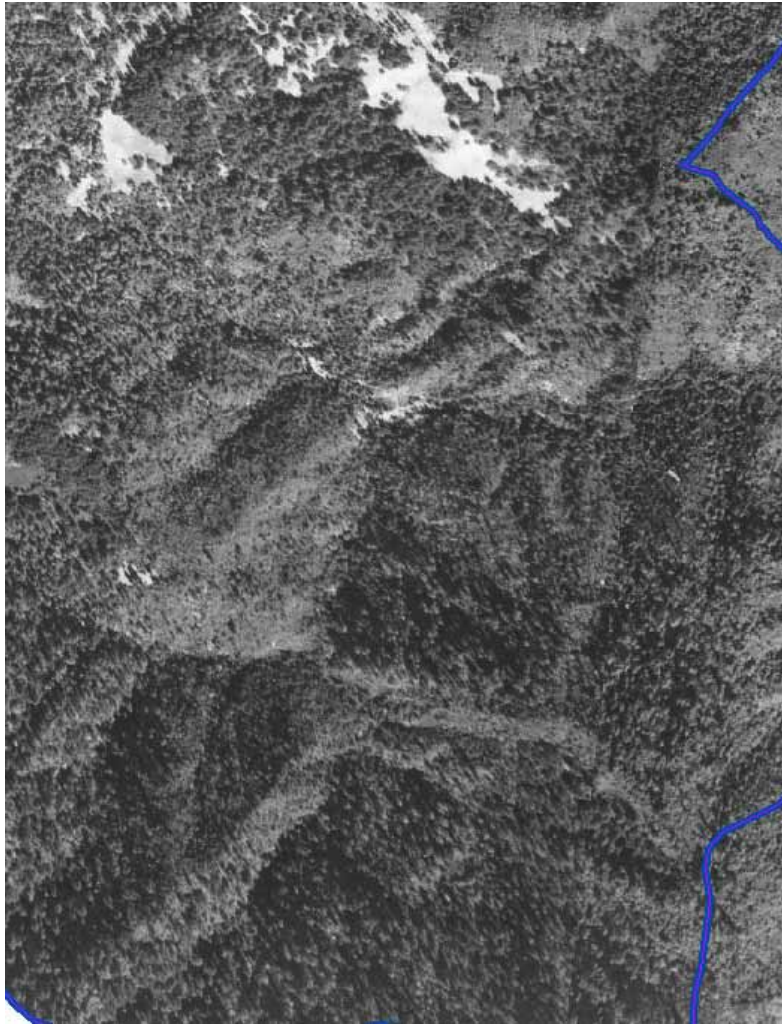
Figure 4. Same location as Figure 3 in 1980 showing lack of conifer regrowth and continued ground disturbance as well as additional timber harvesting

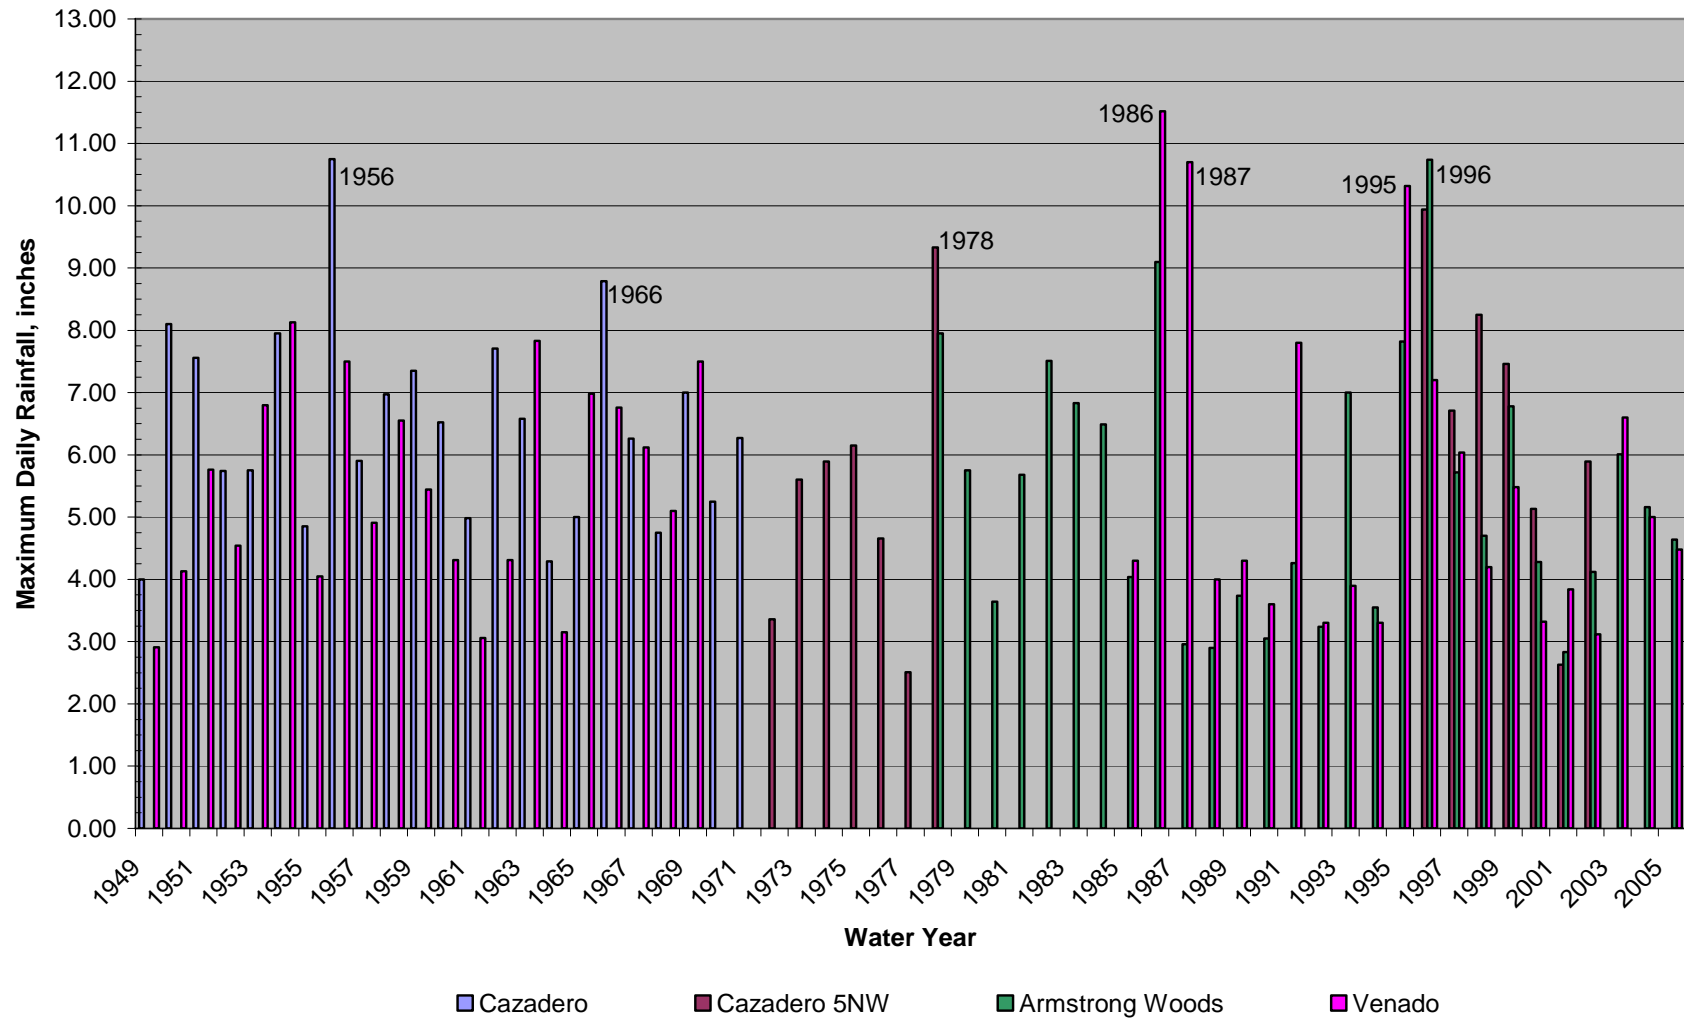
Figure 13. The Annual Maximum Daily Rainfall for Four Stations Near Cazadero

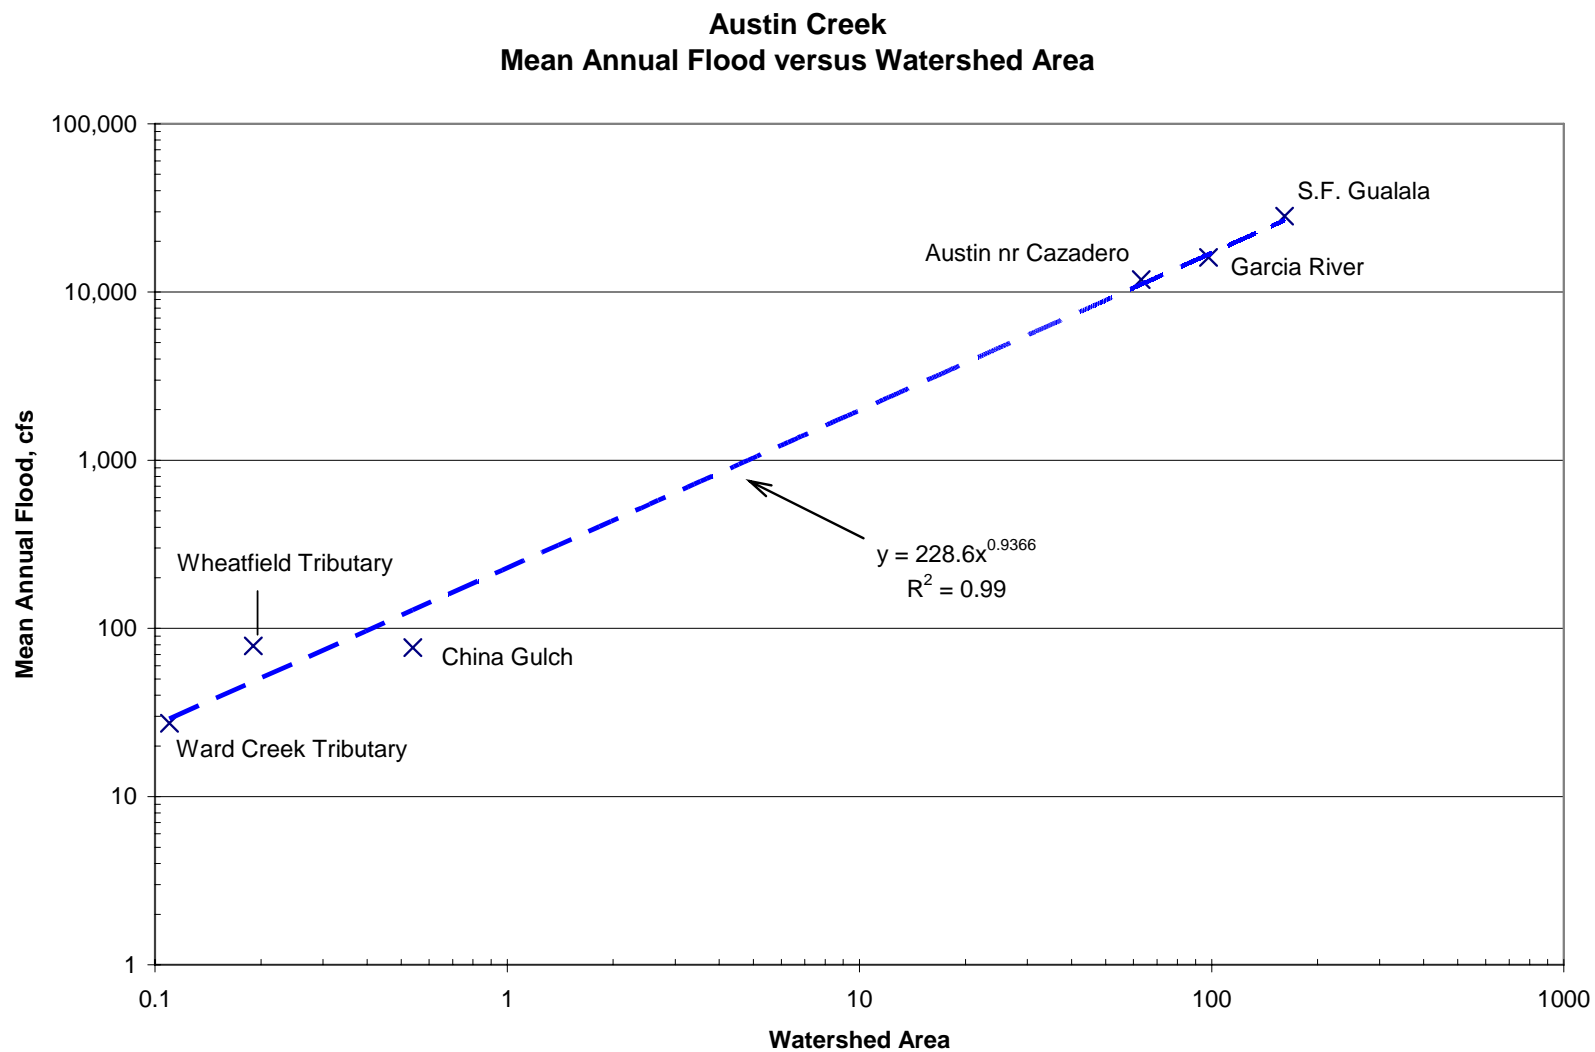
Figure 16. The mean annual flood versus watershed area for six stations near Austin Creek

Station Number	Station Name	Years Record	Area Sq-Mi	Mean Annual Flood cfs	10-Year Flood cfs	15-Year Flood cfs
11467040	Ward C Tributary Near Cazadero Ca	12	0.11	27.4	44.0	46.8
11467200	Austin C Near Cazadero Ca	7	63.1	11,840	15,268	15,856
11467300	Unnamed Tributary To Wheatfield Fork Gualala R Near Annapolis	9	0.19	78.6	139.7	150.2
11467500	S Fork Gualala R Near Annapolis Ca	21	161	28,235	43,103	45,650
11467560	China Gulch	12	0.54	76.9	111.4	117.4
11467600	Garcia River near Point Arena	26	98	16,061	26,998	28,872

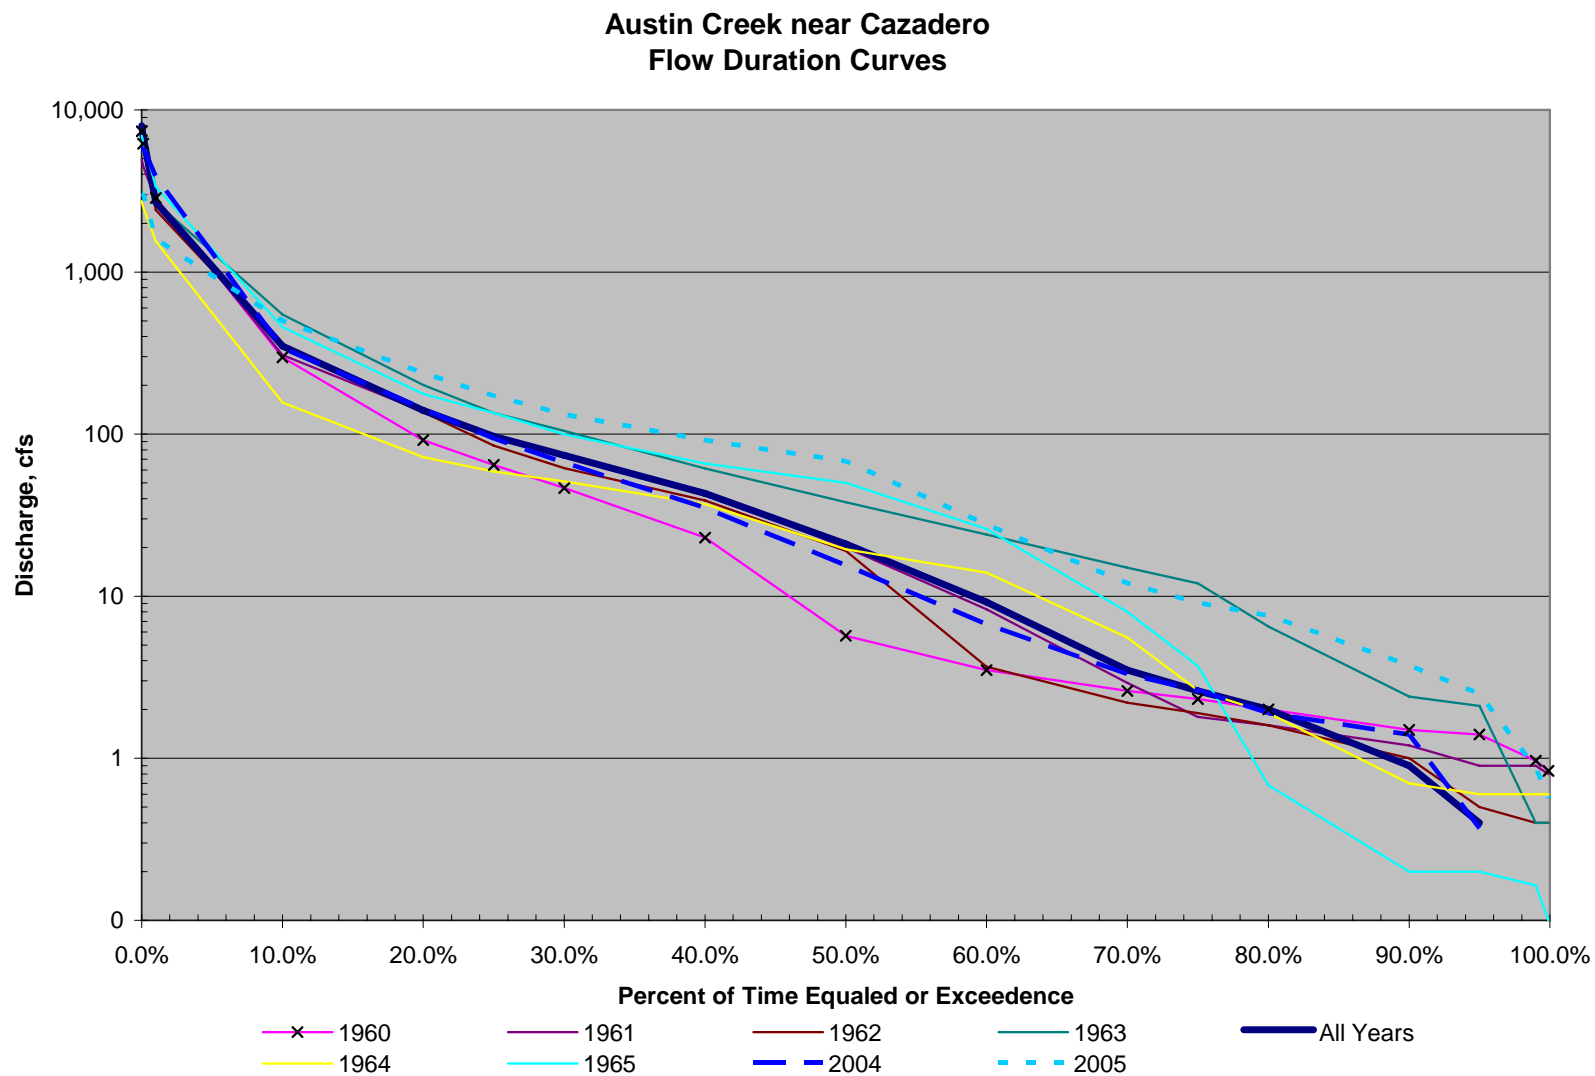
Figure 17. Flow duration curves for the Austin Creek near Cazadero stream gauge

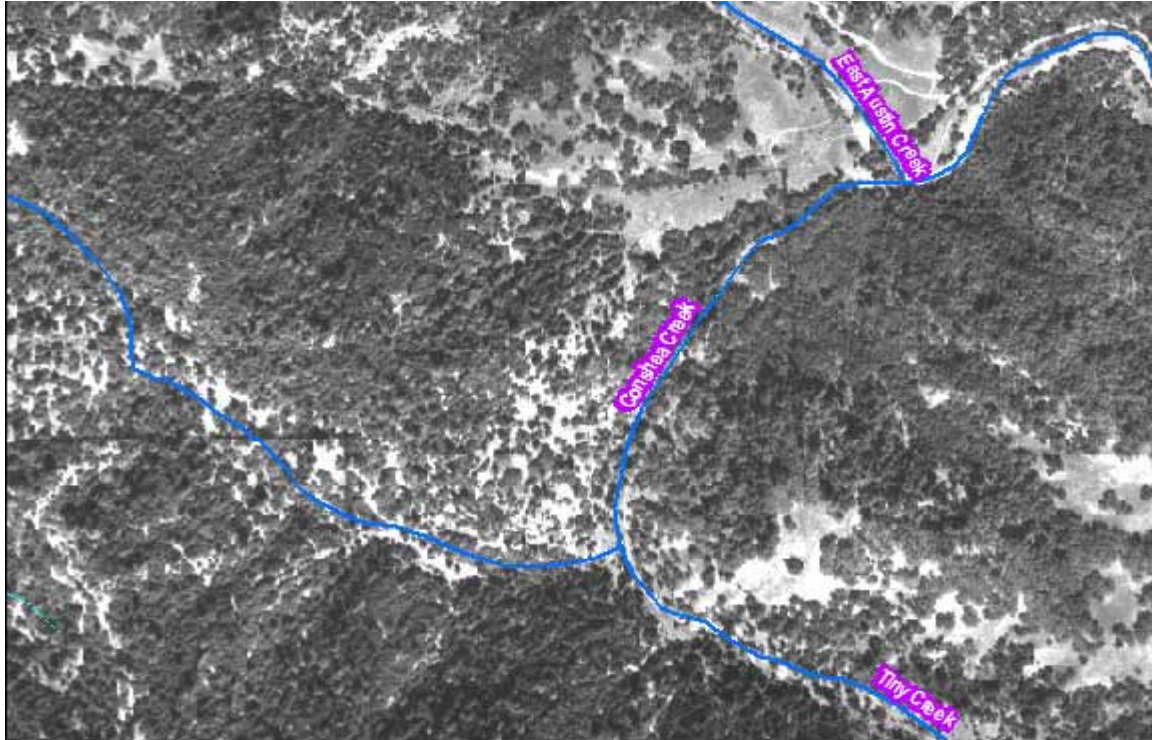
Figure 32. Top photo is Conshea Creek area of Upper East Austin Creek Sub-basin in 1980 showing continued ground disturbance following the 1961 logging. Bottom photo shows same location in 2000 with red outline around example of still disturbed area

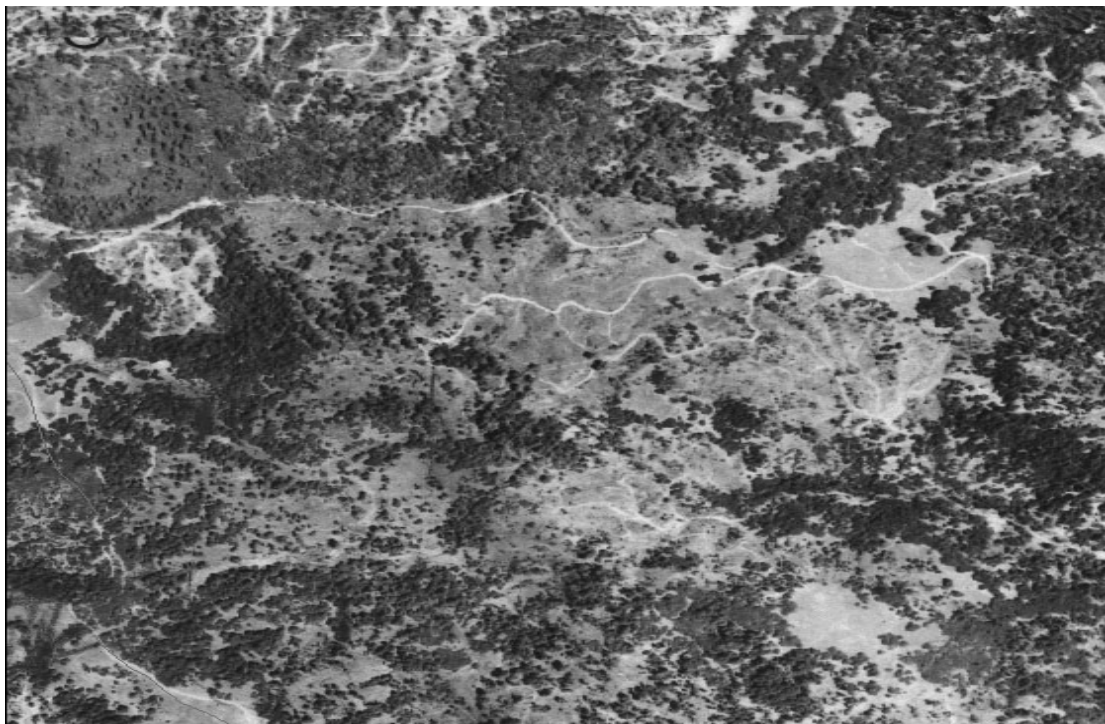
Figure 36. Top photo shows an area of Upper Austin Creek Sub-basin in 1941/42. Bottom photo shows same area in 1961 after clear-cut logging

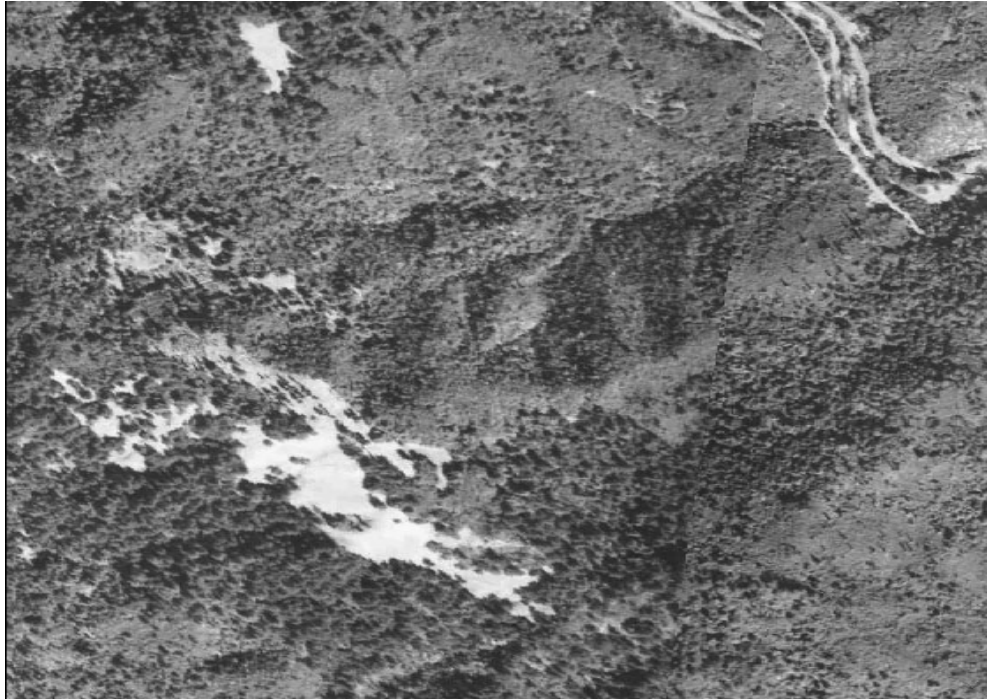
Figure 43. Top photo shows eastern area of Kidd/St. Elmo Creeks Sub-basin in 1941/42 where the conifer forest has been previously logged. Bottom photo is same location in 2000 showing more conifer forest and a number of roads.

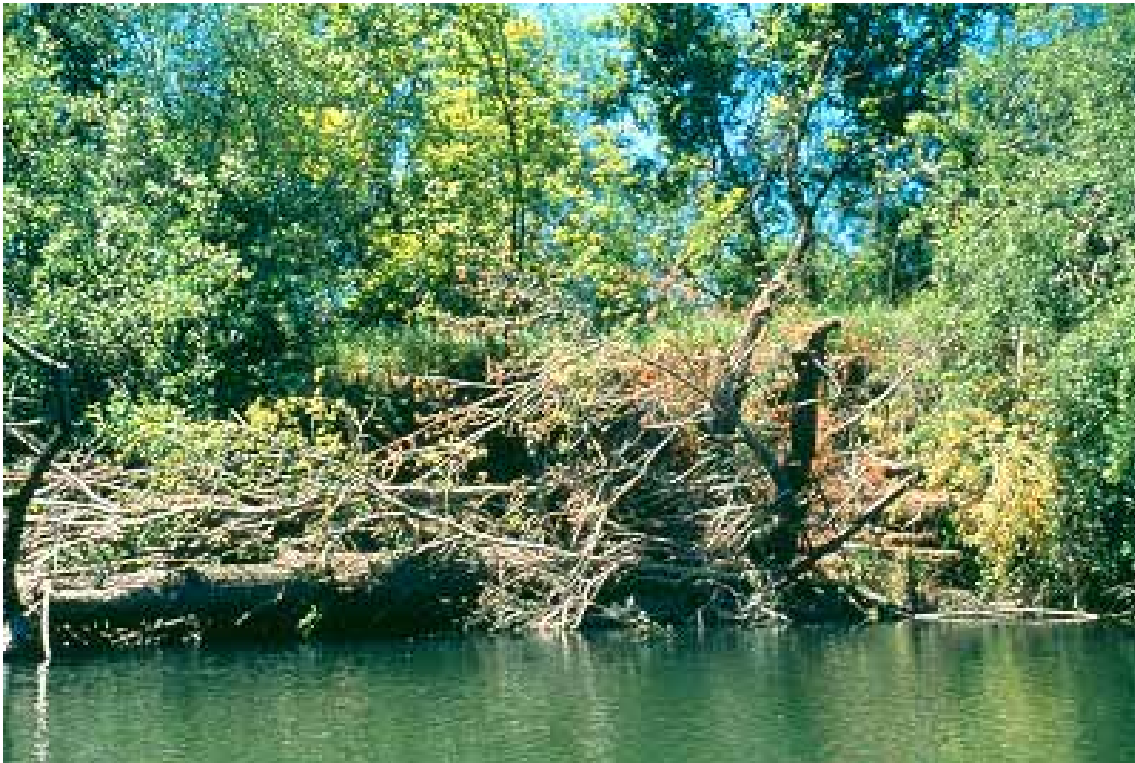
Figure 49. Large woody debris in stream channel creates complex habitat for salmonids. In some creeks large wood in the channel forms pools.
