# **COPELAND CREEK WATERSHED ASSESSMENT**

**Copeland Creek Alluvial Fan Reach**

October 2004

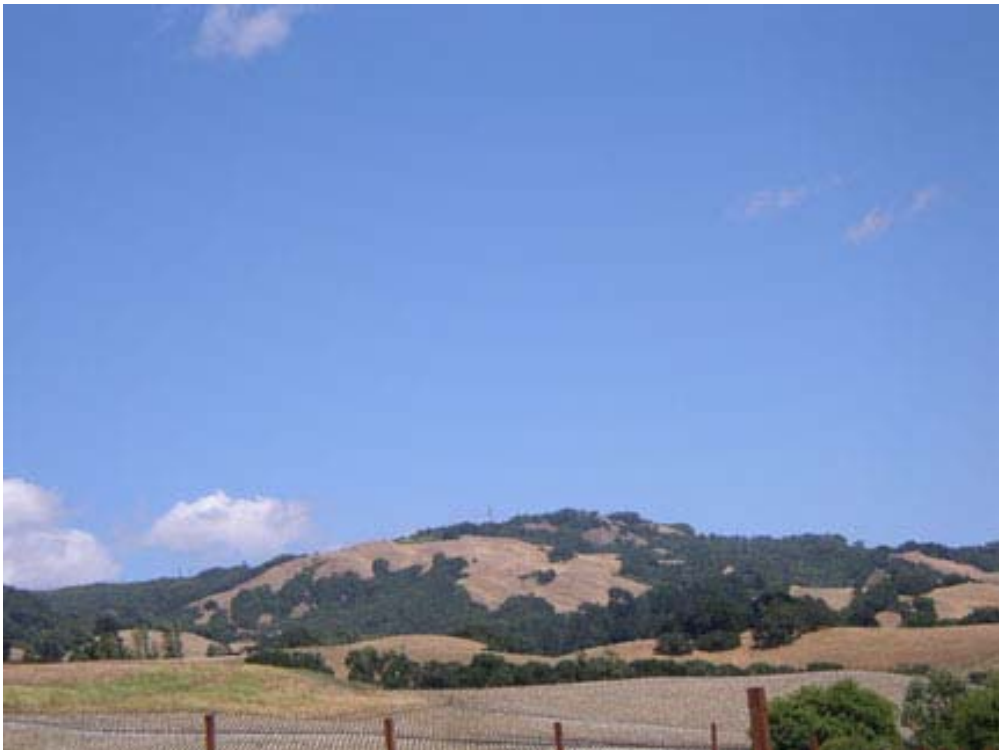
**Figure 10. Wetlands in Hillside of Copeland Creek Indicate Spring Activity.**

Interspersed in the grasslands are numerous springs and seeps in the hillsides of the upper Copeland Creek watershed (see Figures 10 and 11). The Sonoma Volcanic formation that makes up the upper watershed along with the many landslides and seismicity associated with the Rodger Creek and Healdsburg Faults combine to create the many springs, seeps, wetlands and sag ponds. Willow, cottonwoods and a variety of wetland plants, including rushes (*Juncus* sp.), sedges (*Carex* sp.), nutsedge (*Cyperus* sp.), spike-rush (*Eleocharis* sp.), tules (*Scirpus*) and cattails (*Typha* sp.) are found in the many wetland and spring areas.

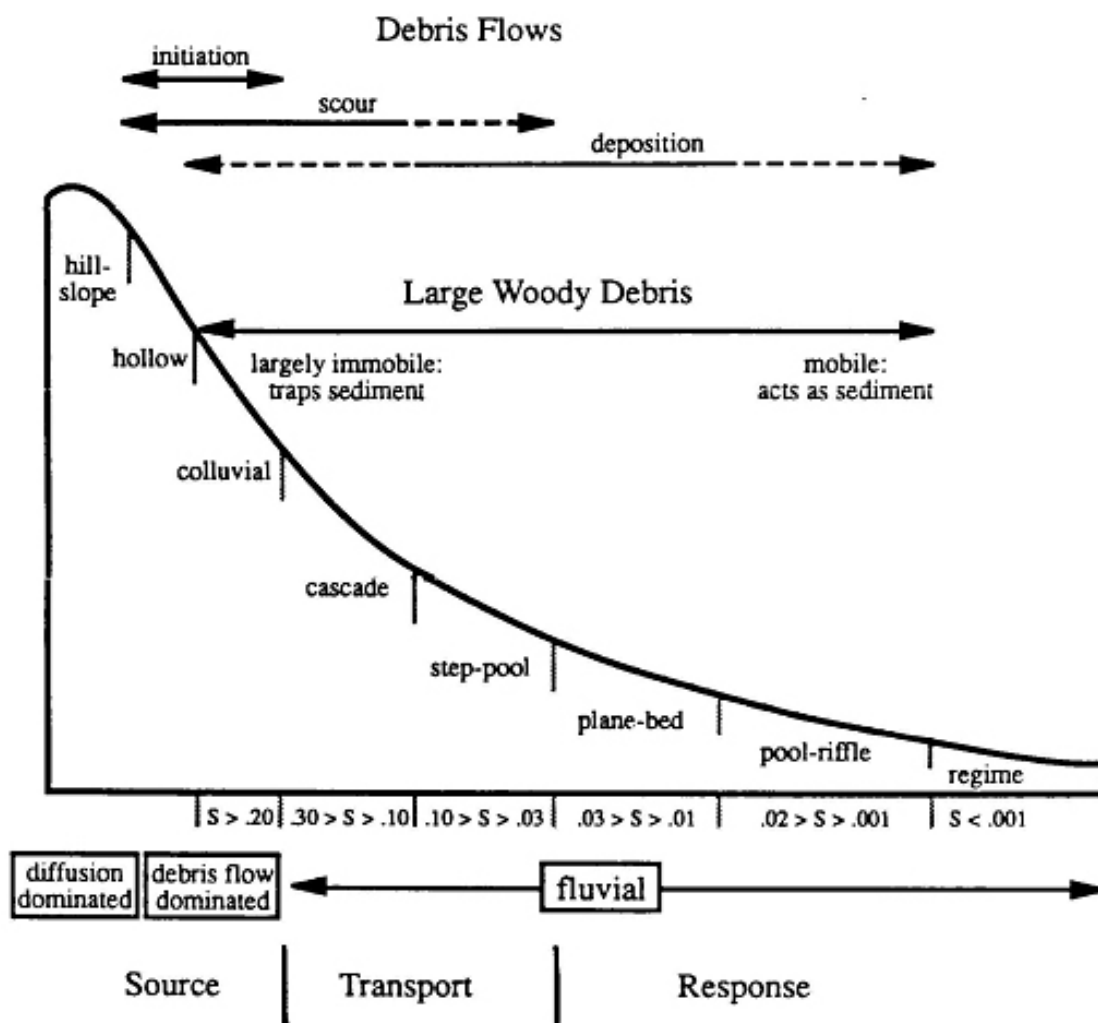
**Figure 26. Channel Types.** This illustration of an idealized stream shows the general distribution of channel types from the hilltop down through the channel network. From Montgomery and Buffington, 1993.

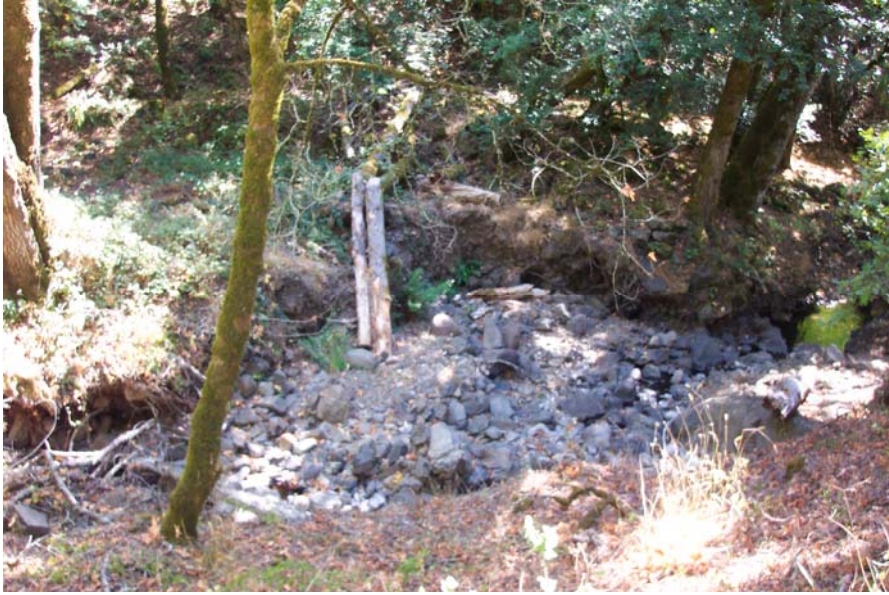
**Figure 29. Copeland Creek Headwaters Reach.**

Copeland Creek is confined upstream of Lichau Road Bridge. The channel slope varies from the 4 to 8 percent class to the 8 to 20 percent class. The creek channel is bound in a narrow canyon in most locations. Figures 28 and 29 show Copeland Creek in the headwaters reach. Copeland Creek in the headwaters reach has large cobbles and boulders, as well as gravel on its channel bed. With the steepness of the hillslopes and ephemeral streams and dominance of landslides, floods in the headwaters reach likely generate large volumes of bedload into Copeland Creek.

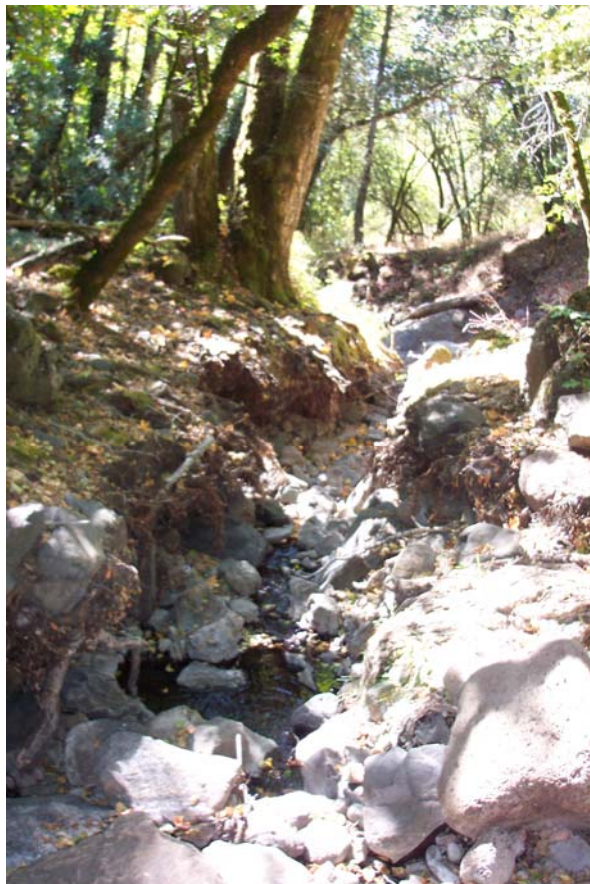
**Figure 30. Beginning of Alluvial Fan Reach.**

This large volume of material is visible just downstream of the confined channel at the Lichau Road Bridge, where Copeland Creek spreads out over an alluvial fan. The alluvial fan reach extends from Lichau Road to just downstream of Petaluma Hill Road and is unconfined, but includes portions of the channel at 2 to 4 percent slope and 1 to 2 percent slope. Figures 30 and 31 show the deposits of cobble and gravel in the alluvial fan adjacent to the current creek channel. A hand-colored map completed by the California Division of Mines and Geology depicts the alluvial fan of Copeland Creek (see Figure 32).

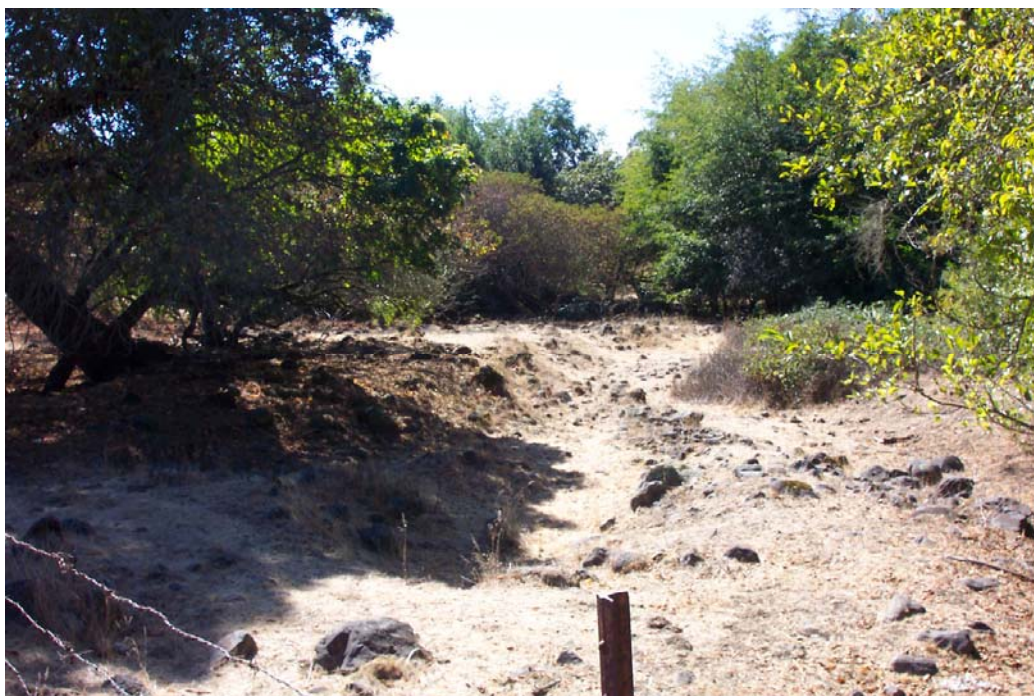
**Figure 31. Deposits of Cobble and Sand on Copeland Creek Floodplain in Alluvial Fan Reach.**

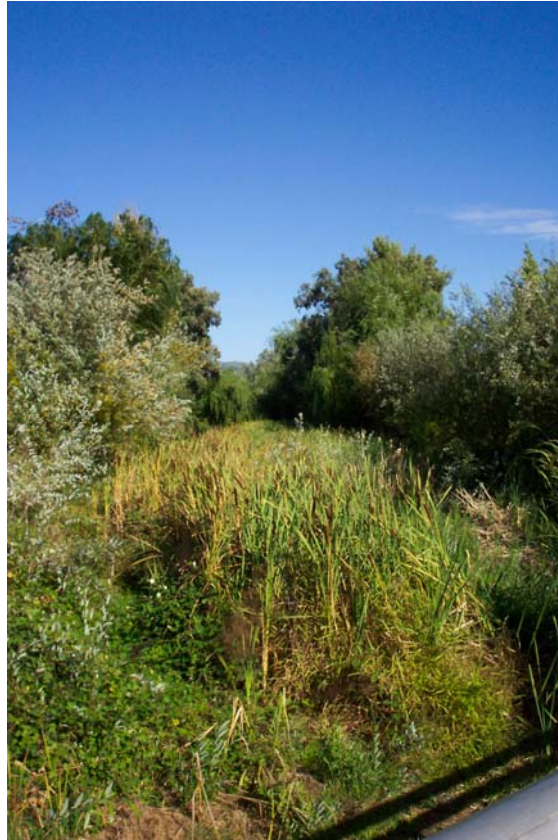
**Figure 33. Copeland Creek Valley Reach.**

In the valley reach of the Copeland Creek watershed, the stream has a low slope (see Figure 33). This area of the watershed has streams that both store and transport sediment and have a floodplain. Prior to European and American settlement, Copeland Creek likely meandered across the Cotati Valley and overflowed into wetland areas. Stormflows slowed down and spread out. Rather than being dominated by large boulders as in the steep channels, gravel, sand and silts likely dominated the channel. When low-slope streams receive large inputs of sediment, even in undeveloped watersheds, it may take years for transport processes to move it out.

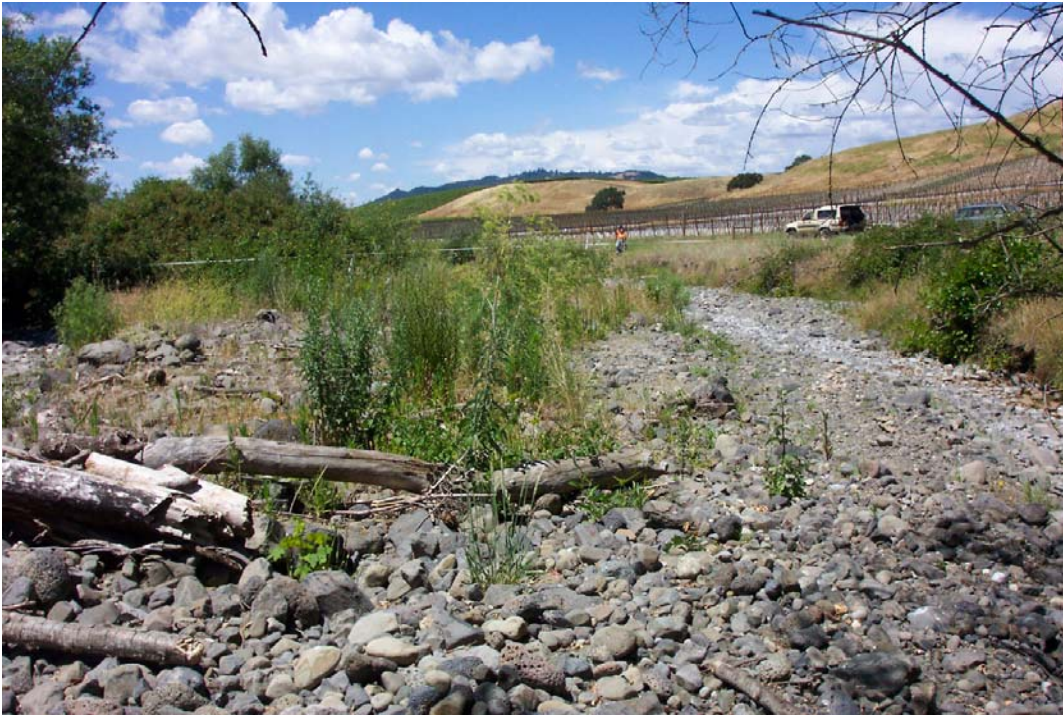
**Figure 34. Copeland Creek in Alluvial Fan Reach in Summer 2004.**

Four observations stood out as we examined Copeland Creek. First, the streambed was covered by cobbles and small boulders (see Figure 34). Second, the width of the active channel was very wide, perhaps about 100 feet from top-of-bank to top-of-bank, which is about four times wider than expected. Third, trees growing below the top-of-bank appear to be no older than about 25-years old. Four, pools were scarce and those that were found were shallow.

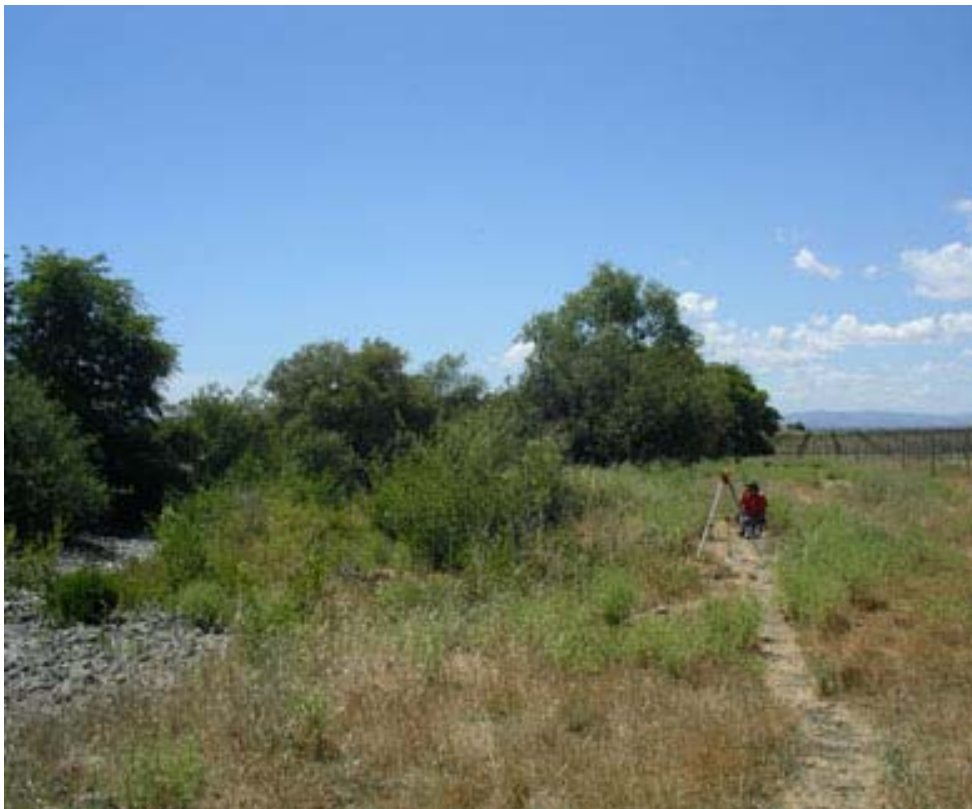
**Figure 35. Surveying Channel Cross-sections of Copeland Creek Study Reach.**

A low volume of surface flow was observed near the Roberts Road Bridge in June 2004. As we progressed upstream, surface flow would appear and disappear. A short distance upstream of the 320-foot contour line, by GPS reading, fish were seen in a small pool at the downstream end of a flowing reach. The small fish appeared to behave like juvenile steelhead. The first cross section of the study reach was placed a few feet downstream of this pool at a point where the channel was dry. The end of the study reach was placed about 330 feet upstream at a point where the flow first appeared. A total of four cross sections were surveyed in addition to a longitudinal profile along the low-flow channel. Graphs of the four cross sections, creek profile and the surveyed profile are shown in Figures 35 to 41.

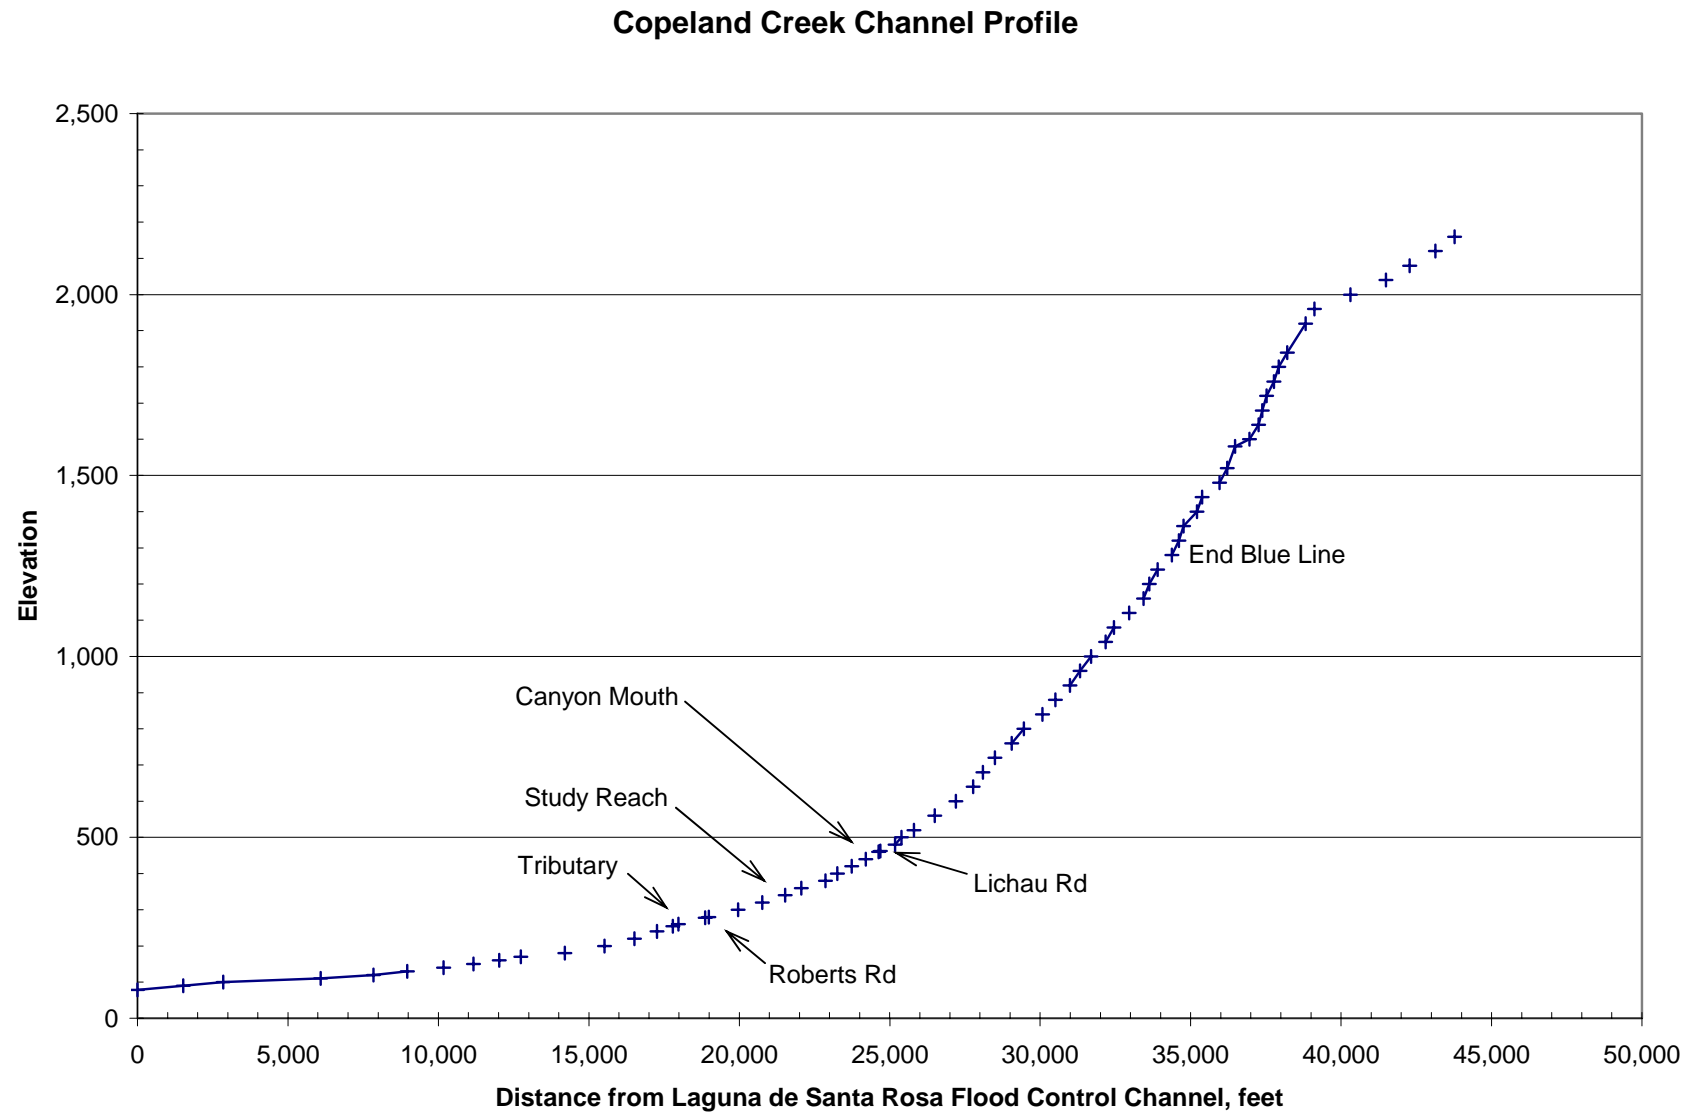
Figure 36. The channel profile was constructed from the USGS topographic map. The study reach is on an alluvial fan.

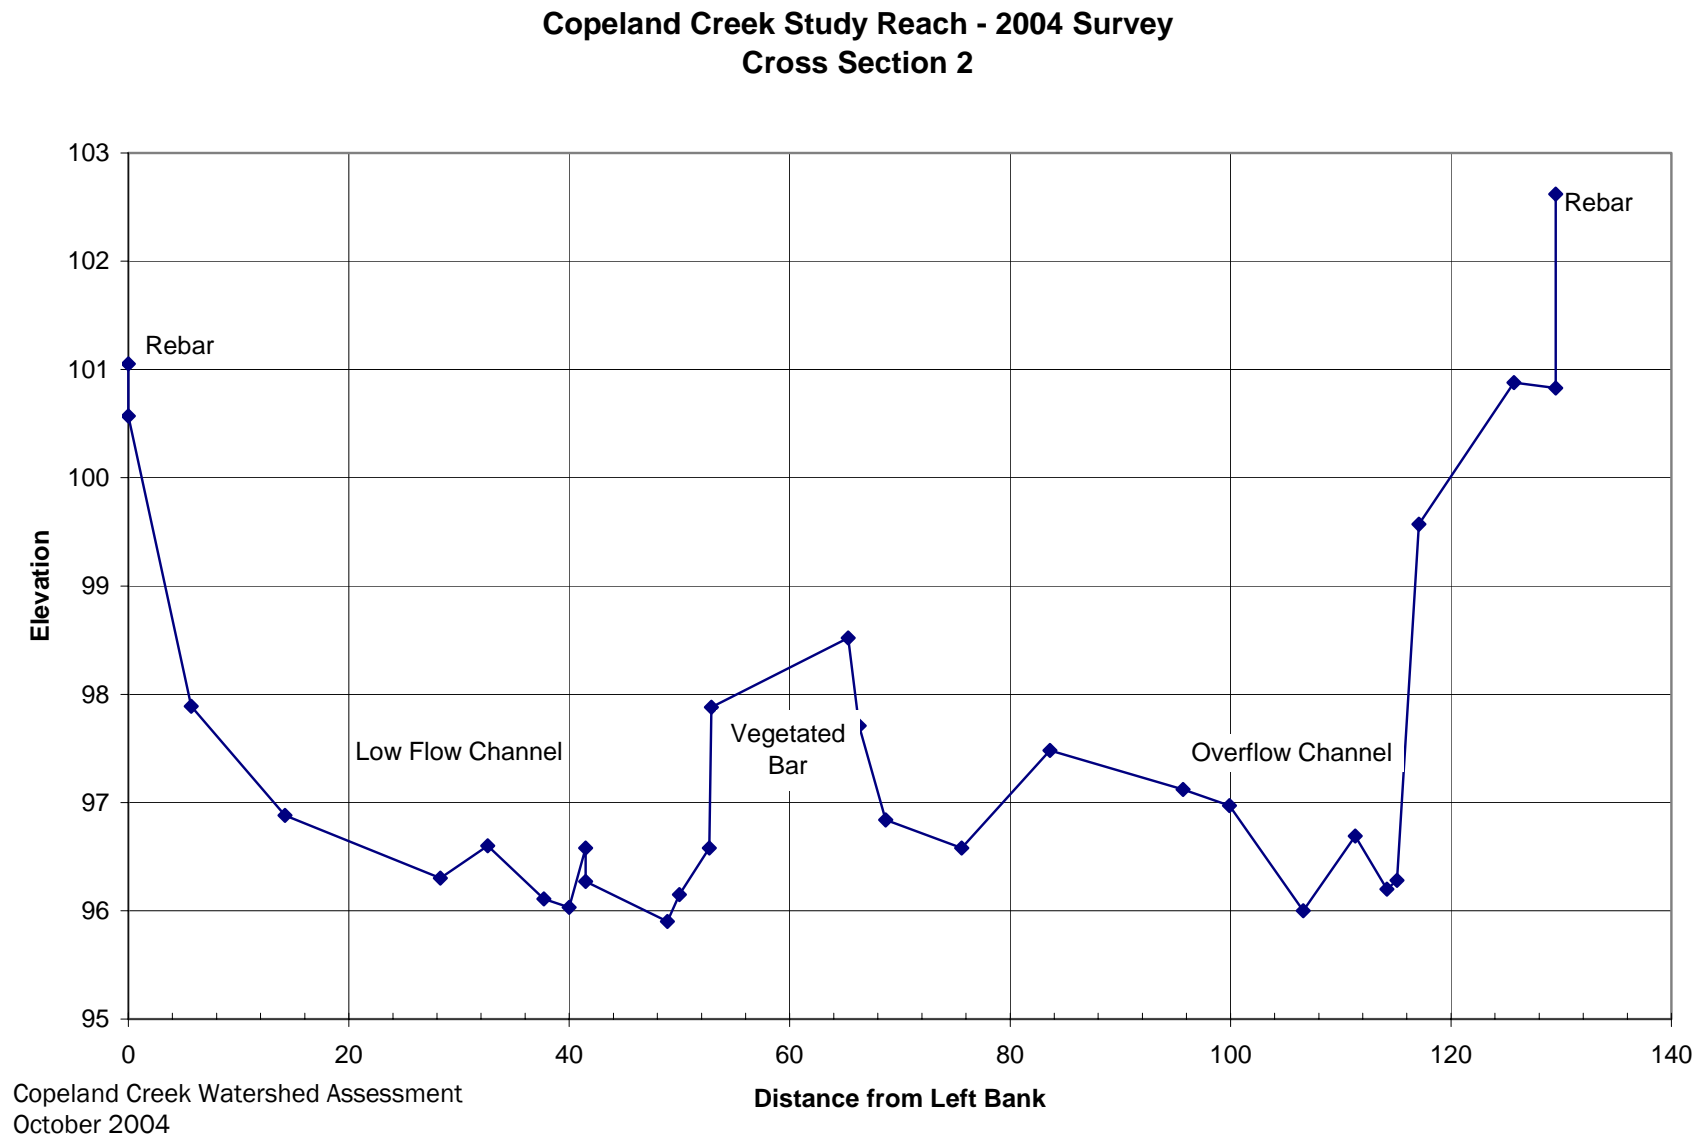
**Figure 39. Cross Section 2.** The channel is divided into a low-flow channel and an overflow channel, separated by a vegetated bar.

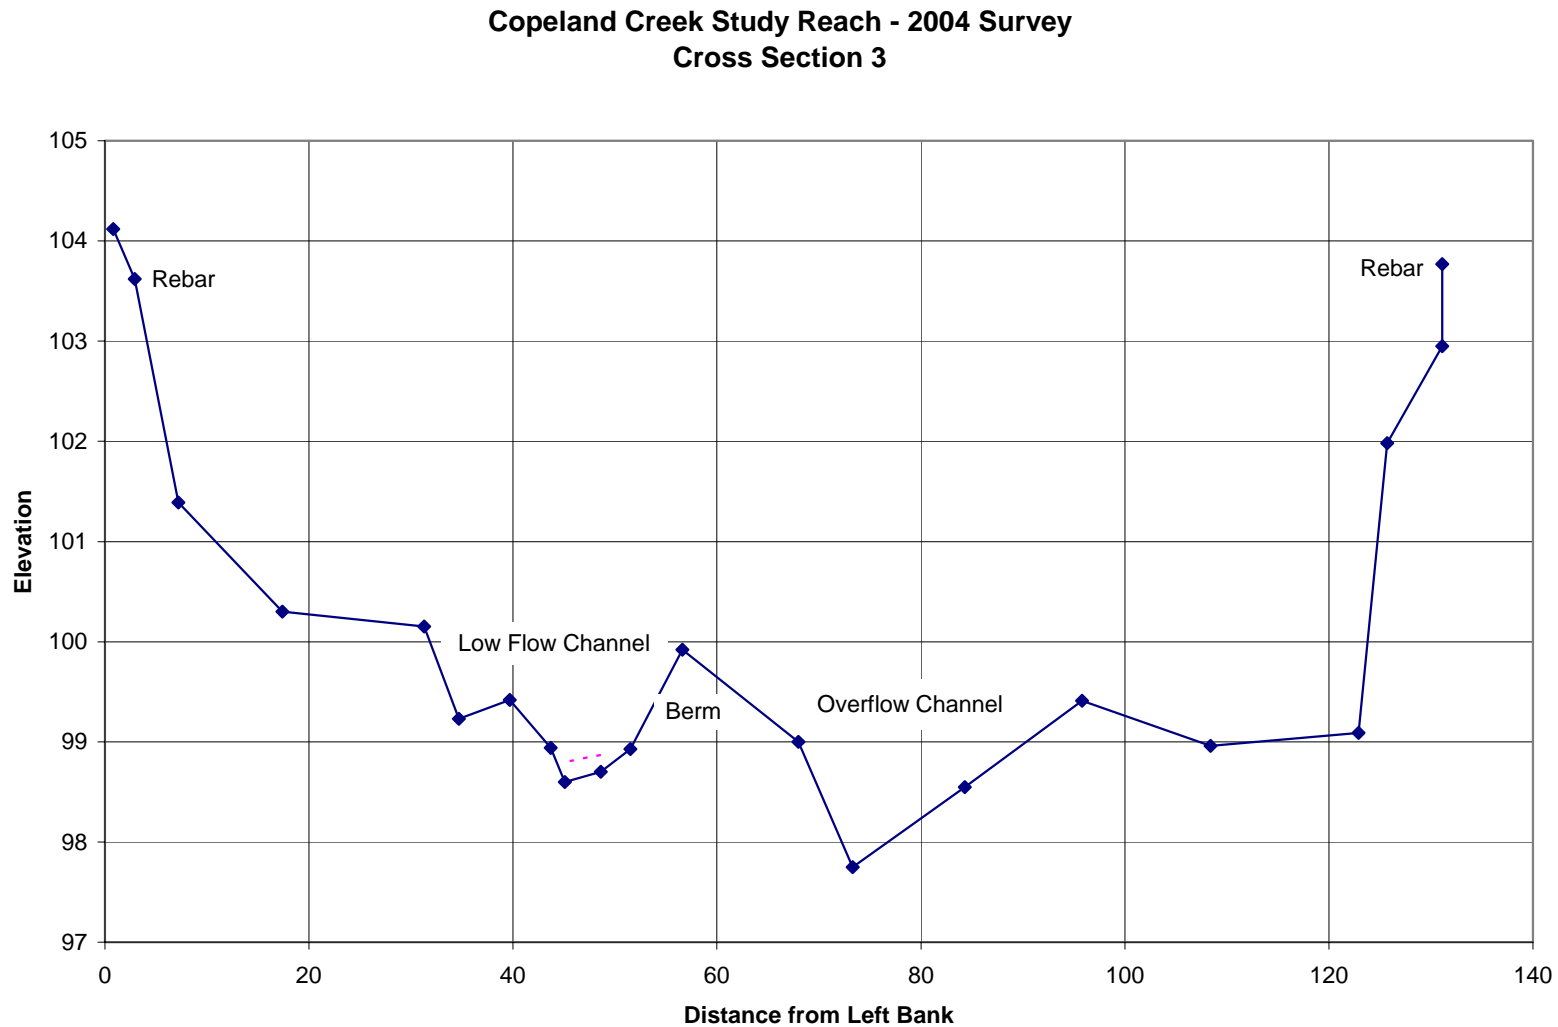
**Figure 40. Cross Section 3.** The channel begins to divide into a low-flow channel and an overflow channel. Upstream of here, the right half of the channel is densely vegetated with an overflow channel at the base of the right bank.

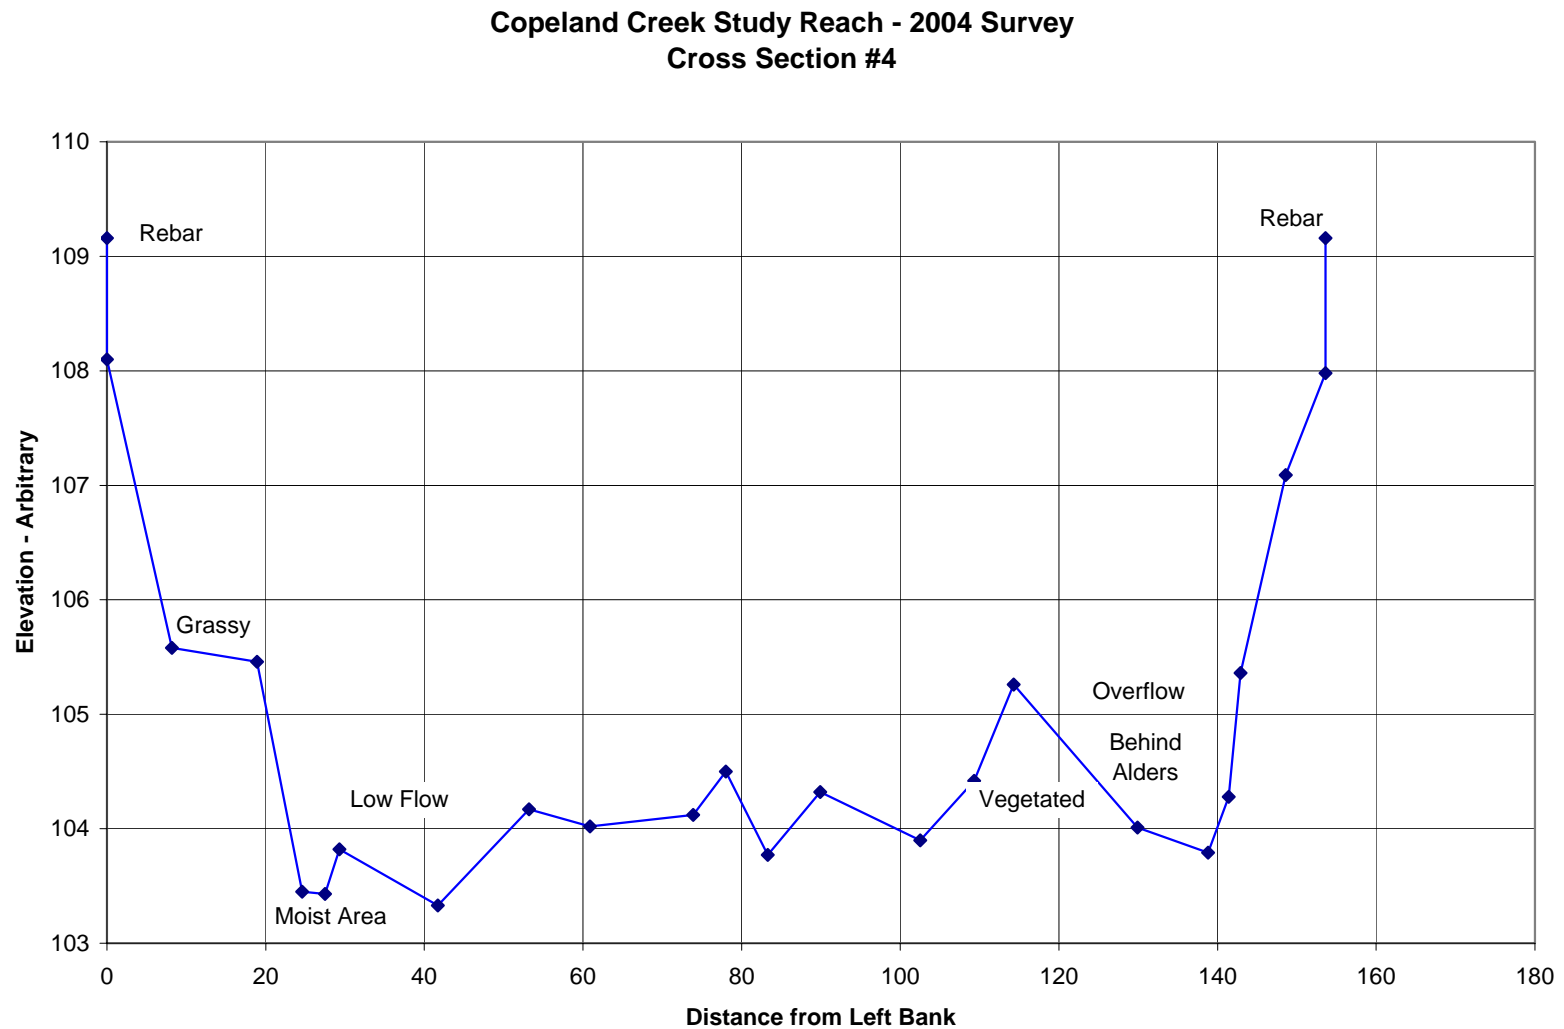
**Figure 41. Cross Section 4.** An overflow channel at the base of the right bank runs down to cross section 3. Surface flow begins just downstream of the cross section. Stand water was seen about three feet upstream of the cross section near the left bank.

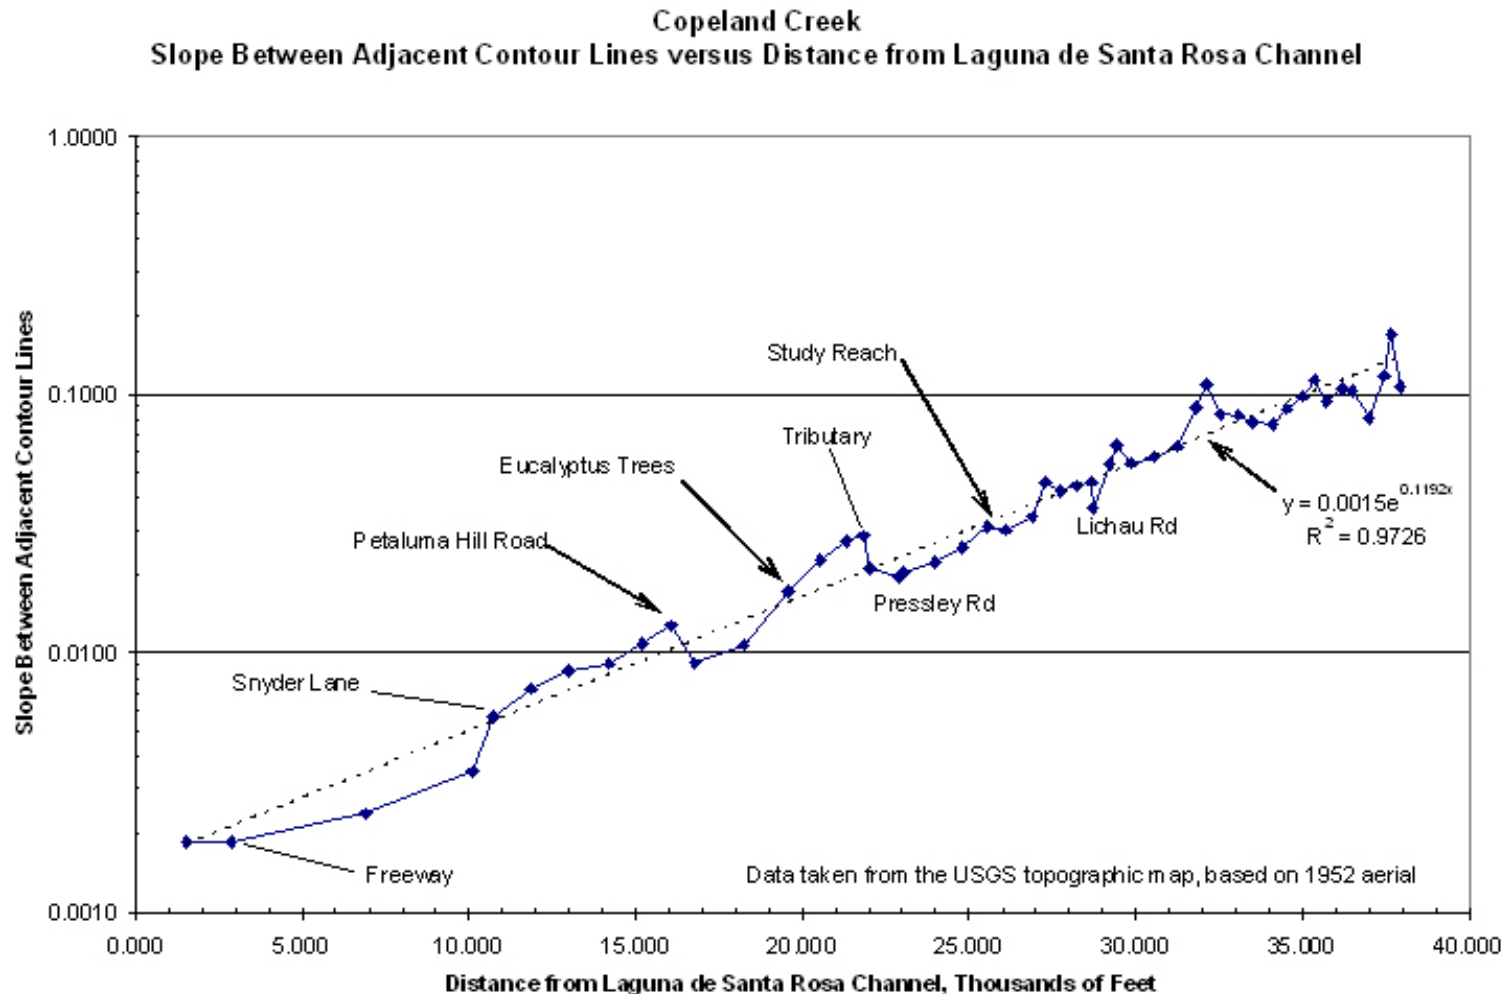
**Figure 47. Slope at Each Contour Line, Calculated Between the Previous and Next Contour Line, Versus the Distance from the Laguna de Santa Rosa Channel.** An exponential function was fit to the data using linear regression. The exponential function represents the expected slope. Note that the upstream side of the bridges at Petaluma Hill Road, Roberts Road and Lichau Road all have lower than expected slopes. The survey of the study reach produced a channel slope of 0.029. The slope between adjacent contours in the vicinity of the study reach was 0.03.

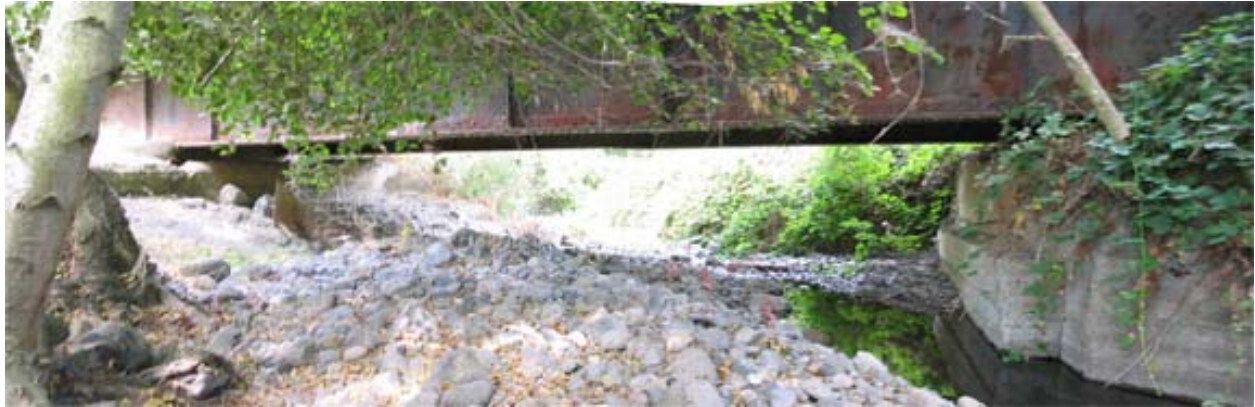
**Figure 48. The underside of the Roberts Road Bridge over Copeland Creek Viewed from Upstream.** The distance between the bridge abutments is roughly 40 feet and the distance from the water surface to the bottom of the bridge is roughly 5 feet. The bridge may constrict floods with a return period greater than roughly about 10-years.

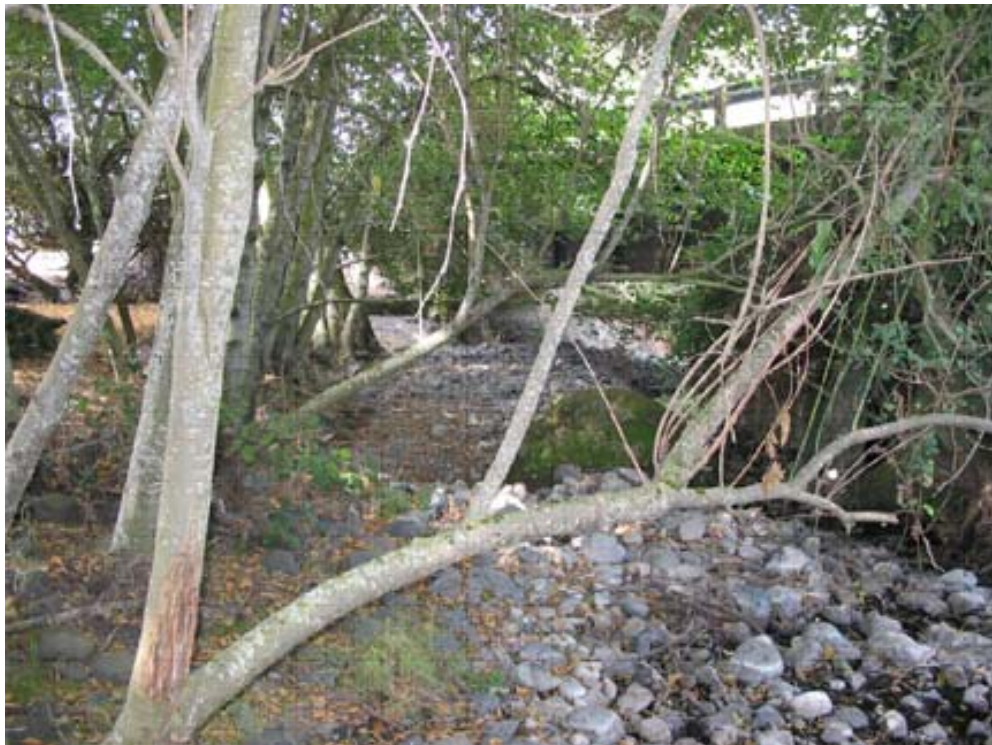
**Figure 49. Looking Downstream at the Roberts Road Bridge over Copeland Creek.** The bottom width of the active channel upstream of the bridge is about 20 feet. The bankfull width was not measured but is probably about 30 feet, which is in fair agreement with the predicted bankfull width of 24 feet. Note that a floodplain has developed on the left bank. The bridge constricts floods with a return period greater than about 10-years. The floodplain may have been maintained upstream of the bridge because large catastrophic floods are constricted by the bridge. During a large catastrophic flood, the reach upstream of the bridge would be in a backwater area.

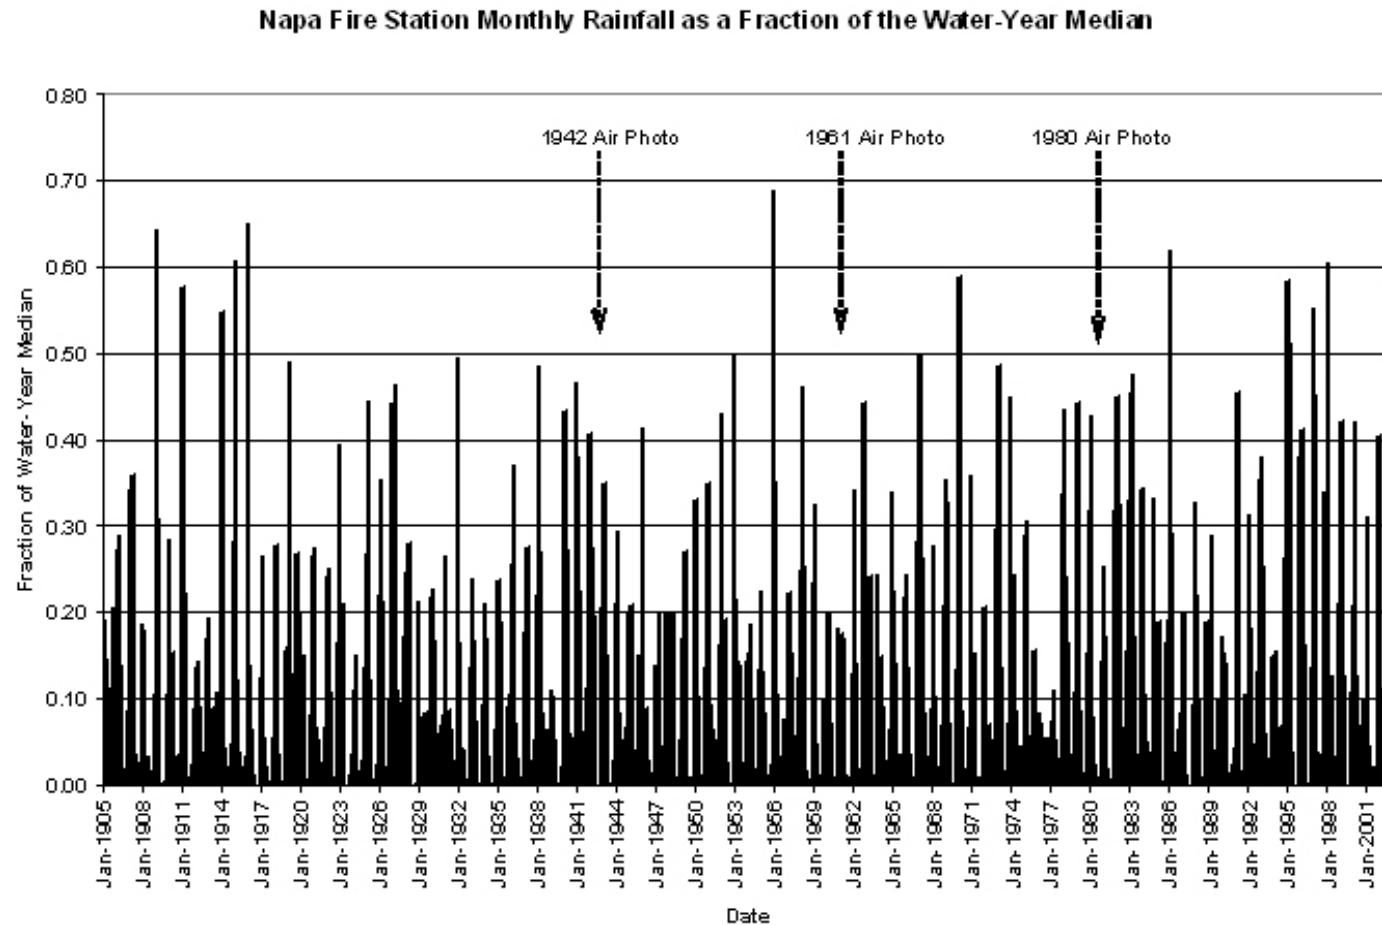
**Figure 50. Napa Fire Station Monthly Rainfall for 1905 to 2002 as a Fraction of the Water-Year Median Rainfall.** The water-year median rainfall for the Napa Fire Station is 23.41". Months with rainfall greater than 0.50 are associated with large flood events. January of 1909, 1911, 1914, 1915 and 1916 all had rainfall in excess of 0.5 of the annual water-year median rainfall. There was also a very large storm in December 1861.

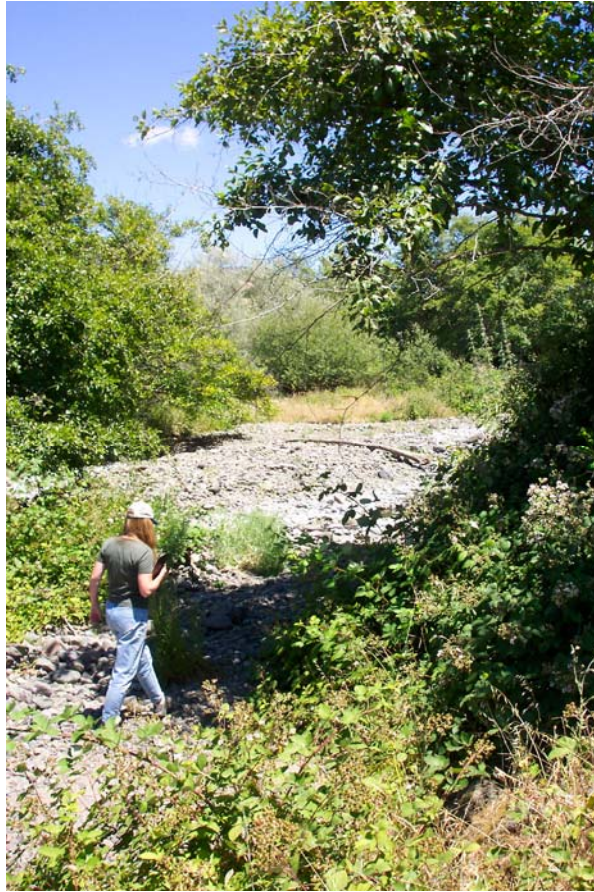
**Figure 53. Sparse Vegetation and Large Size Bed Material of Copeland Creek in Alluvial Fan Reach.**

of creek channels without any vegetation. There are white alder (*Alnus rhombifolia*), red willow (*Salix laevigata*), sandbar willow (*Salix sessilifolia*), *Psoralea macrostachya* and large amounts of non-native Himalayan blackberry (*Rubus discolor*) growing along the main creek channel. The alders and willow are relatively young, maybe 20 to 25 years old and may represent a period of re-growth following a very major storm. Throughout this reach the creek has multiple channels, very little mature vegetation and only sparse young vegetation (Figures 52 and 53). This reach of Copeland Creek had intermittent flow by July and was largely dry by September 2004.

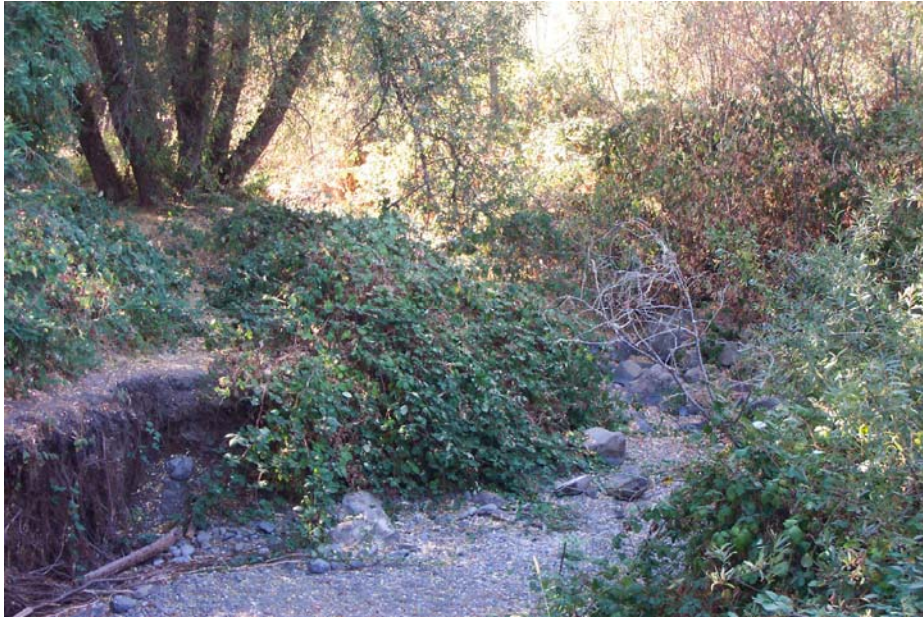
**Figure 54. Copeland Creek Channel on Sonoma State University Campus.**  
Note Gravel and Cobble on the Channel Bed.

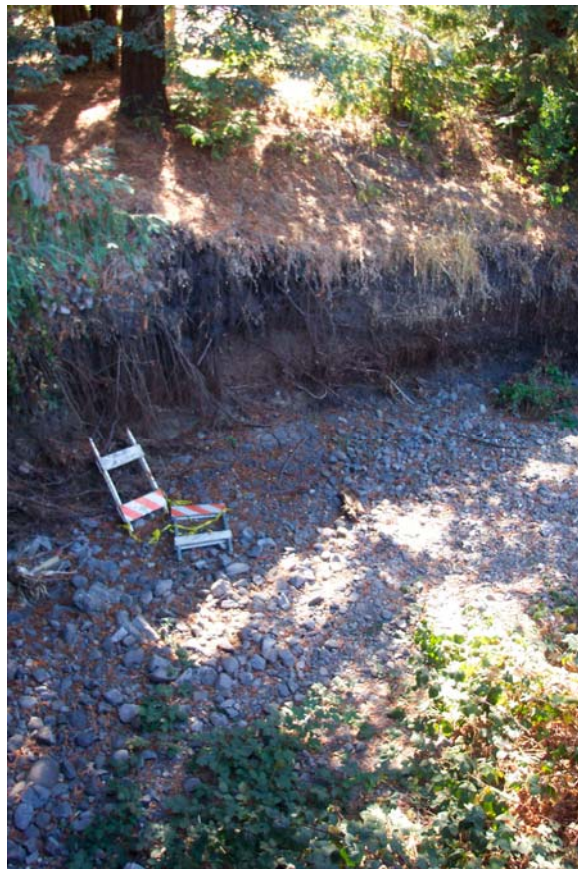
**Figure 56. Copeland Creek Riparian Corridor on Sonoma State University Campus with New Plantings.**

In the upstream area of this reach, Copeland Creek is somewhat natural in the SSU area. The creek has a level of sinuosity, and pool and riffle bedforms (see Figures 54 and 55). There are low (5 to 10 feet) levees along the channel on the floodplain. Mature willow dominates the riparian corridor with Himalayan blackberry very abundant in many locations. A number of different native trees have been planted – coast redwood (*Sequoiadendron sempervirens*) big leaf maple (*Acer macrophyllum*), live oak (*Quercus agrifolia*), Fremont cottonwood (*Populus fremontii*) along with native grasses and understory species (see Figure 56 and 57).

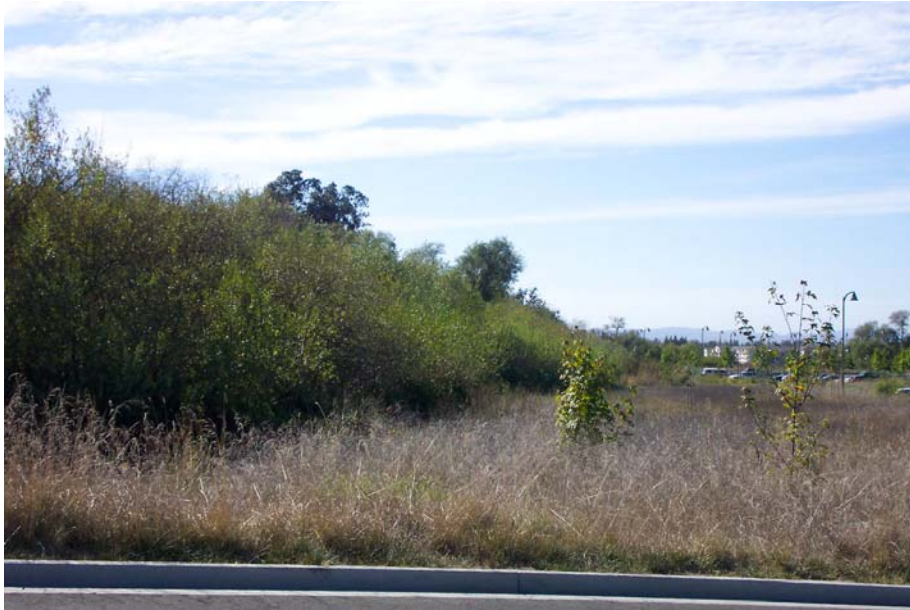
**Figure 57. Big Leaf Maple Planted on Edge of Copeland Creek Corridor.**

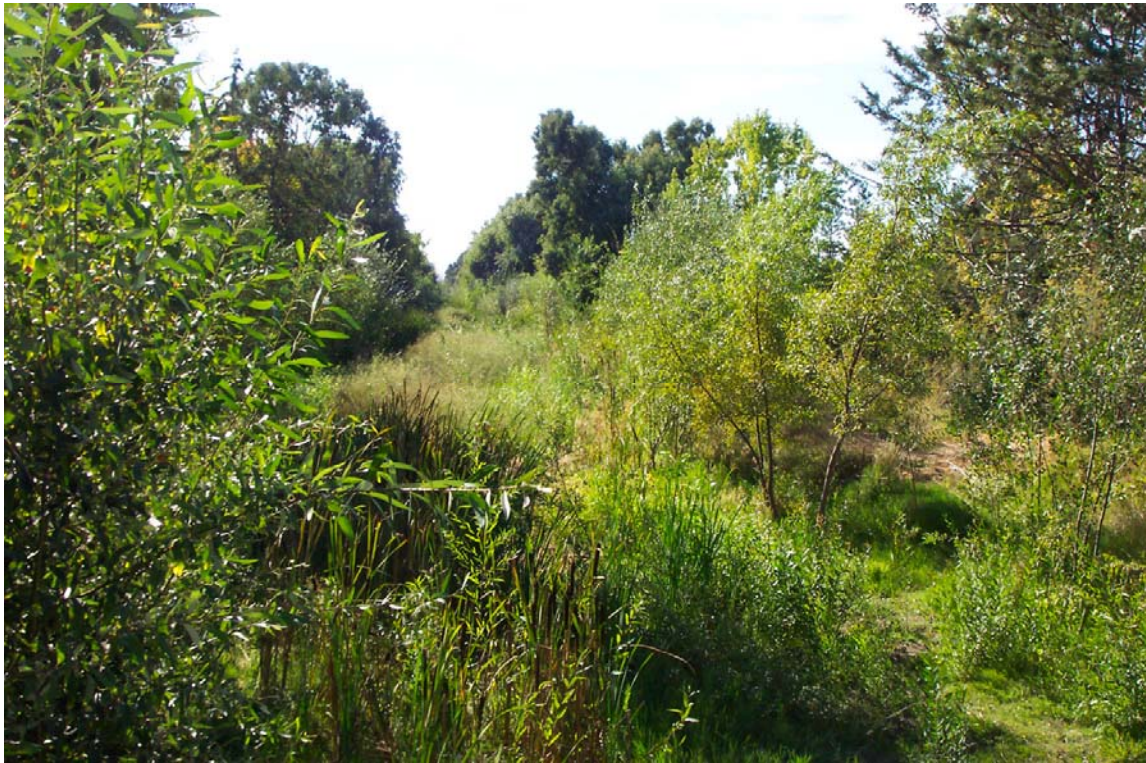
**Figure 58. Copeland Creek Flood Control Channel at Snyder Lane Bridge.**

Downstream in the valley reach, Copeland Creek is a flood control channel with no sinuosity or bedforms in the channel and a row of trees and shrubs such as willow, eucalyptus, black locust, weeping willow, Himalayan blackberry and pampas grass along the edge of the channel (Figure 58 to 63). There are herbaceous wetland plants, such as cattails (*Typha latifolia*) and sedges (*Carex* sp.) growing in the channel bottom. The channel appears aggraded with silt and sand and dries up in the summer.
