# **COPELAND CREEK WATERSHED ASSESSMENT**

**Copeland Creek Alluvial Fan Reach**

October 2004

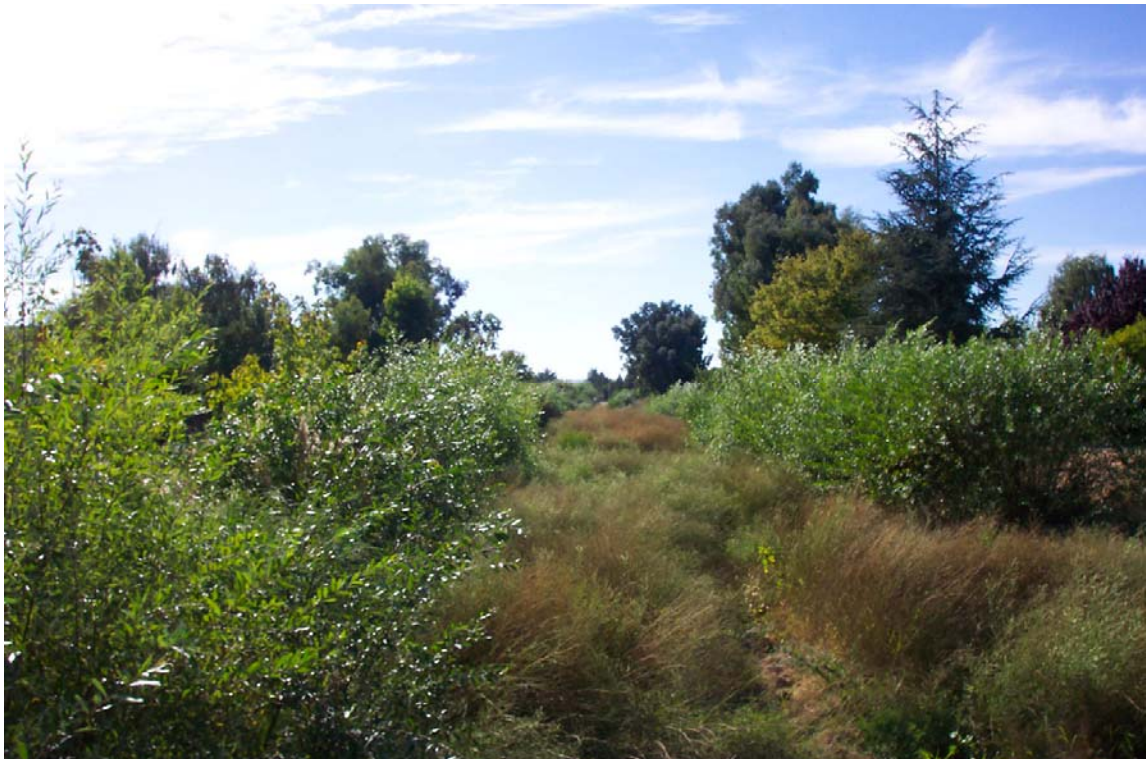
**Figure 60. Country Club Drive Bridge and Copeland Creek Channel with Invasive Non-native Pampass Grass.**

Downstream in the valley reach, Copeland Creek is a flood control channel with no sinuosity or bedforms in the channel and a row of trees and shrubs such as willow, eucalyptus, black locust, weeping willow, Himalayan blackberry and pampas grass along the edge of the channel (Figure 58 to 63). There are herbaceous wetland plants, such as cattails (*Typha latifolia*) and sedges (*Carex* sp.) growing in the channel bottom. The channel appears aggraded with silt and sand and dries up in the summer.

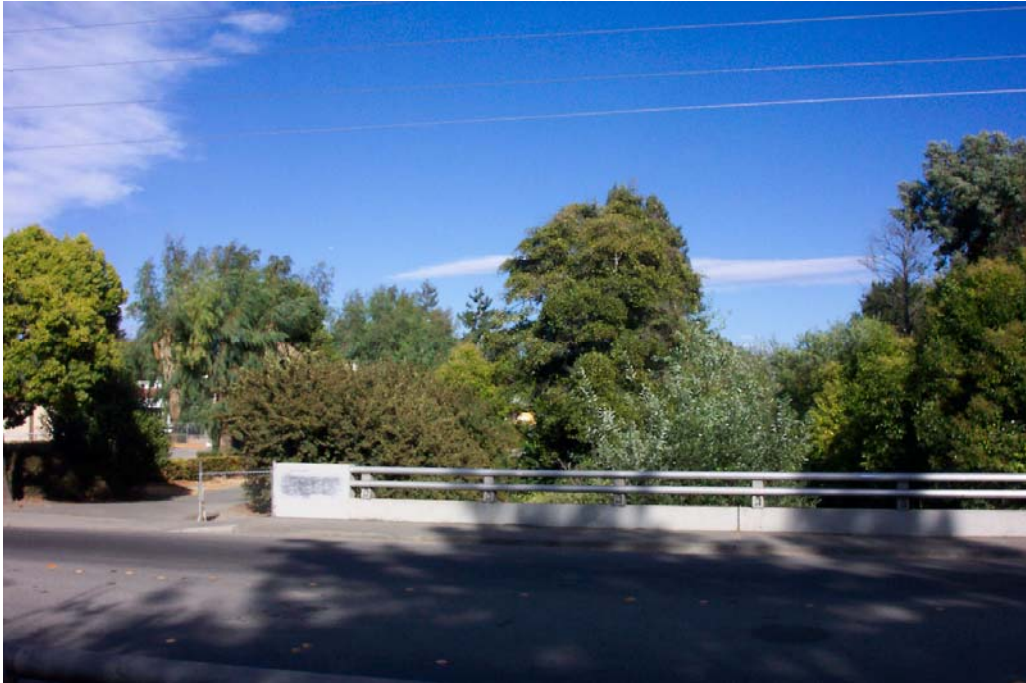
**Figure 63. View of Copeland Creek from Commerce Blvd. Bridge. Note dense Himalayan blackberry in channel.**

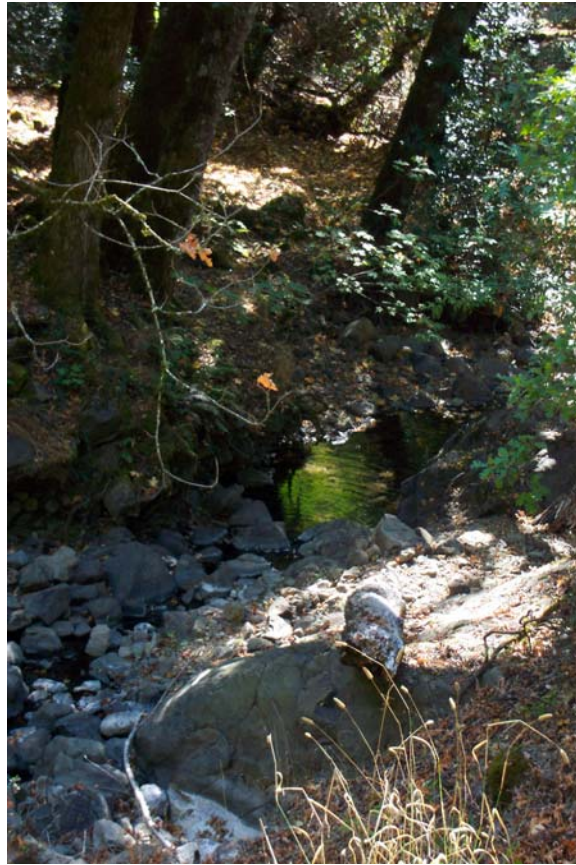
**Figure 65. Copeland Creek Near Monitoring Site Two in Direct Sun with Algal Bloom.**

Water temperature was monitored over the June to September 2004 period in two areas of Copeland Creek (Figure 7). Table 13 lists the features of the five water temperature monitoring stations. These two areas of Copeland Creek are very different (Figure 64 and 65). Stations Copeland-45, 50 and 55 are in the headwaters reach (Monitoring Site 1) of the creek in a confined channel with perennial flows and dense evergreen riparian canopy. Stations Copeland-10 and 30 are in the alluvial fan reach (Monitoring Site 2) with intermittent flow and semi-dry conditions and a more open canopy of young riparian trees. Two air temperature stations were also monitored.
