Lower Mill Creek Surface Water & Groundwater Interactions Report for Water Years 2018 – 2020

**Trout Unlimited
June 2021**

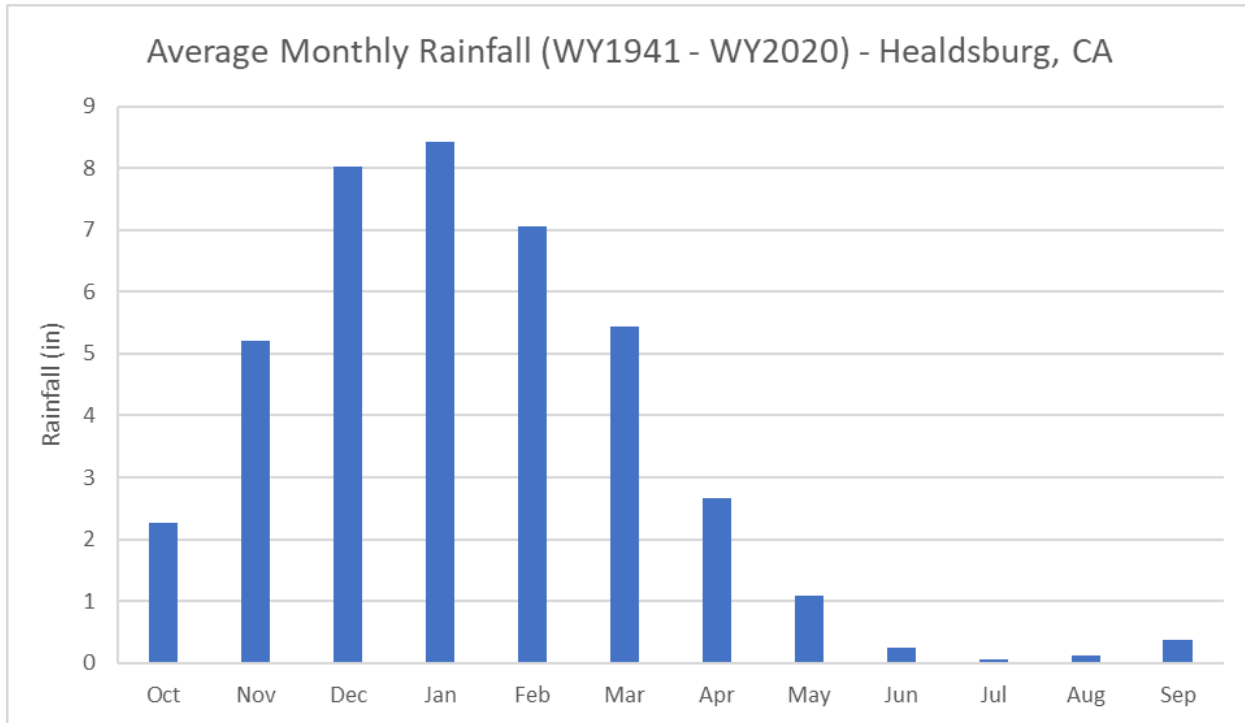
Figure 4. Average monthly rainfall in inches over the period of record (WY1941 – WY2020) recorded at the NCDC Station (USC00043875) in Healdsburg, CA.

Rainfall data collected over a 79-year period recorded at the nearest city, Healdsburg, CA (approximately 1 mile from the Mill Creek watershed), show that 90 percent of the average annual rainfall occurs during the wet half of the year November through April; less than 2 percent of the average annual rainfall occurs from June through September (Figure 4). While the total amount of rainfall may be variable from one year to the next, the seasonality of precipitation is consistent among all years.

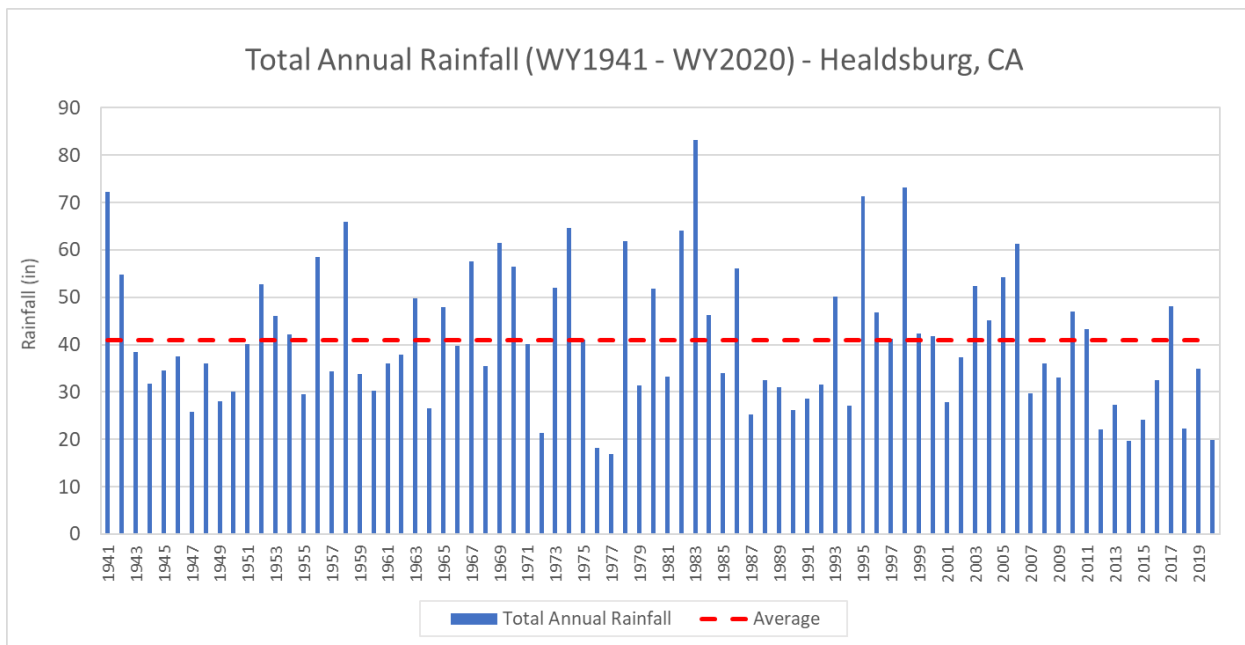
Figure 5. Total annual rainfall compared to the long-term average (40.95) in inches over the period of record (WY1941 – WY2020) recorded at the NCDC Station (USC00043875) in Healdsburg, CA.

These long-term records indicate that rainfall can be variable from one year to the next. Over the 79-year period 1941 to 2020, annual rainfall has varied from as low as 16 inches to as much as 83 inches, with

extended periods of low and of high rainfall throughout the historical record (Figure 5). Most notably, the drought of 2012-2015 represents one of two periods of below-average rainfall for four or more consecutive years: the other was 1989-1992. All three years of the study period (2018 – 2020) experienced below-average rainfall (Figure 6).

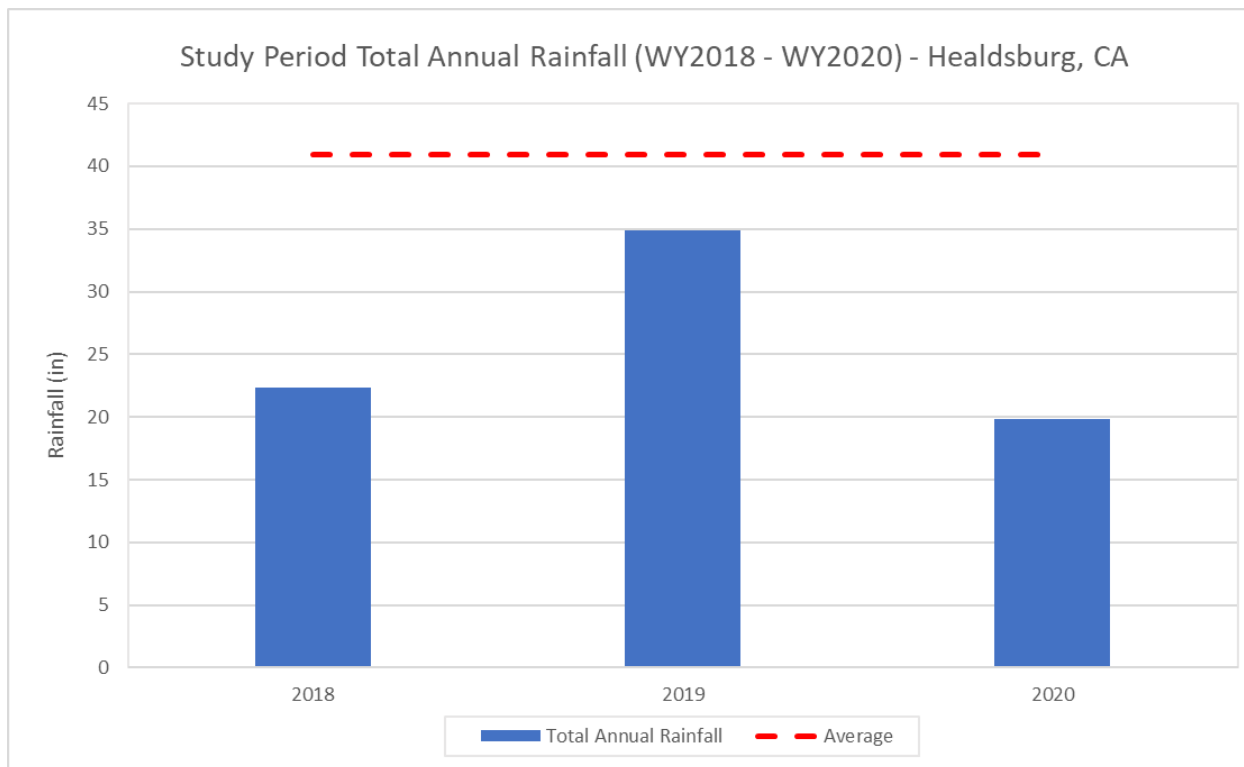
Figure 6. Total annual rainfall for the study period (WY2018 - WY2020) compared to the long-term average in inches recorded at the NCDC Station (USC00043875) in Healdsburg, CA.

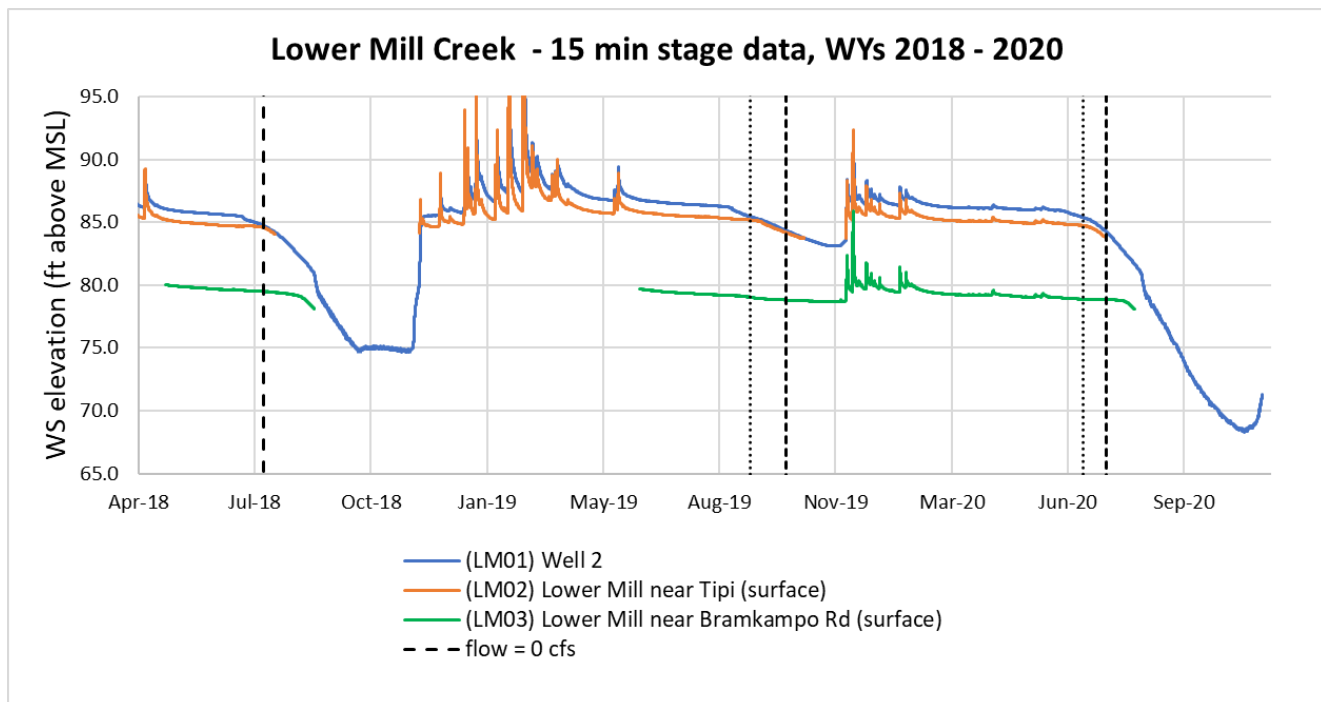
Figure 9. Water surface elevation (ft above MSL) for two surface water gages and one continuous groundwater gage, Lower Mill Creek, WY2020.

Figure 9 displays the stage data collected in 15-minute increments for the two surface water gages (LM02 and LM03) and the continuous groundwater well gage (LM01) collected over the entire study period. All stage data has been converted from an arbitrary datum to feet above mean sea level using data from a TU total station survey, which was conducted in July 2018. Slight elevation adjustments (approximately less than 1 ft) were made during gage repairs in the spring of 2019 and 2020; adjustments were then made to the stage data to provide continuous stage records. The upstream surface water gage (LM02) and groundwater gage (LM01) were installed in late March 2018. The downstream surface water gage (LM03) was installed in late April 2018, after the last spring storm of the season.

At the time of installation, the data show that groundwater was higher than the adjacent surface water, although some of this elevation difference is likely due to the well's location (about 400 ft upstream of the surface water gage). A few days after installation, the last major rain event of the season occurred, and a spike in stage was observed both in the surface and groundwater, a result expected from a well located adjacent to the channel. Following the storm, water levels receded at both gages, with groundwater higher than and feeding the surface water through June 2018. In late June, the drop in groundwater levels accelerated, and within a few weeks dropped to the same level as the surface water. On July 17, flow in the stream reached 0 ft³/sec, though the channel held water in disconnected pools for a few days to weeks after. Groundwater continued to drop sharply until early October, when levels stabilized at about 75 ft above MSL – roughly 12 ft below where they had been in the spring, and approximately 10 feet below the channel flow line. The downstream surface water gage (LM03) was installed in late April 2018, after the last spring storm of the season. Flow slowly receded through spring and early summer, reaching 0 ft³/sec on July 18, 2018. Water in the gage pool here remained for a few weeks after the channel disconnected. The gage pool dried out on August 30, 2018, coinciding with a second steep drop in groundwater levels observed at the LM01 groundwater gage.

In the beginning of water year 2019, the level was at a low point from the previous dry water year (2018), levelling out at about 75 feet above MSL. LM02 and LM03 were dry early in the water year. The LM03 gage was washed out during large winter storms, and data from early June onward is displayed here. Groundwater level began to rise with the onset of winter storms in late November 2018. Following this rise, the channel re-wetted and inundated the gage pool at LM02, and from late December onward, both surface and groundwater levels rose and fell with the numerous winter storms that occurred. The largest storm was in late February 2019 – both ground and surface water level rose over 17 feet during this event. Water levels slowly receded during the dry season. Streamflow remained connected at LM02 until in mid-September, and remained connected until mid-October at LM03. Water was observed to be held in pools at LM03 throughout the dry season. Due to the wetter year, groundwater levels did not drop as steeply as was observed in the fall of 2018.

At the beginning of water year 2020, in October 2019, stage at all three gages was at its dry season low. Streamflow had disconnected at LM02 in mid-September 2019, and at LM03 in mid-October. Groundwater levels at LM01 reached their lowest levels in late November 2019 at about 83 ft above MSL. The upstream LM02 gage pool dried in late October 2019, whereas the downstream LM03 gage pool retained water through the 2019 dry season. Stage began rising at all sites in late November with the arrival of the first storms of the year. Both surface and groundwater stage rose and fell in response to rain events. Stage at all three sites reached a peak on December 7, 2019, during the largest storm of the year. During this storm as well as during the smaller peaks, surface water at LM02 exceeded the level of groundwater at LM01. At all other times, the groundwater level exceeds the surface water level. It should be noted that LM01 is slightly upstream of LM02, and a slightly higher elevation is expected.

The last peak of the rainy season occurred on January 21, 2020, and after this storm stage at all three sites slowly receded. Flow in the channel disconnected on June 22, 2020. Water in the gage pools remained for a few weeks after disconnection. The LM02 gage pool dried out on July 11, 2020, and the LM03 gage pool dried out on August 4, 2020. The pools drying coincided with a steep drop in groundwater levels observed at the LM01 groundwater gage. From August through mid-November 2020, groundwater levels dropped to a low point of 68.5 ft above MSL.

Water year 2020 was the driest year during the study period, with flow disconnecting in mid-June upstream and mid-July downstream, compared to mid-July in water year 2018, and Mid-September through mid-October in 2019. Water year 2018 was also a dry year, and similar to water year 2020, groundwater levels dropped rapidly after the channel dried, but did not reach as low of a level as in water year 2020. Water year 2019 was the wettest year in our study, and the spring recession and channel disconnection came later, and pools in the downstream reach held water year-round. This led to a slower drop in groundwater levels, and as a result levels dropped only slightly before rising again in winter 2020. Winter 2020 had many fewer storms compared to 2019. The early spring recession and channel drying coincided with groundwater levels dropping to the lowest level in our records in late fall 2020.

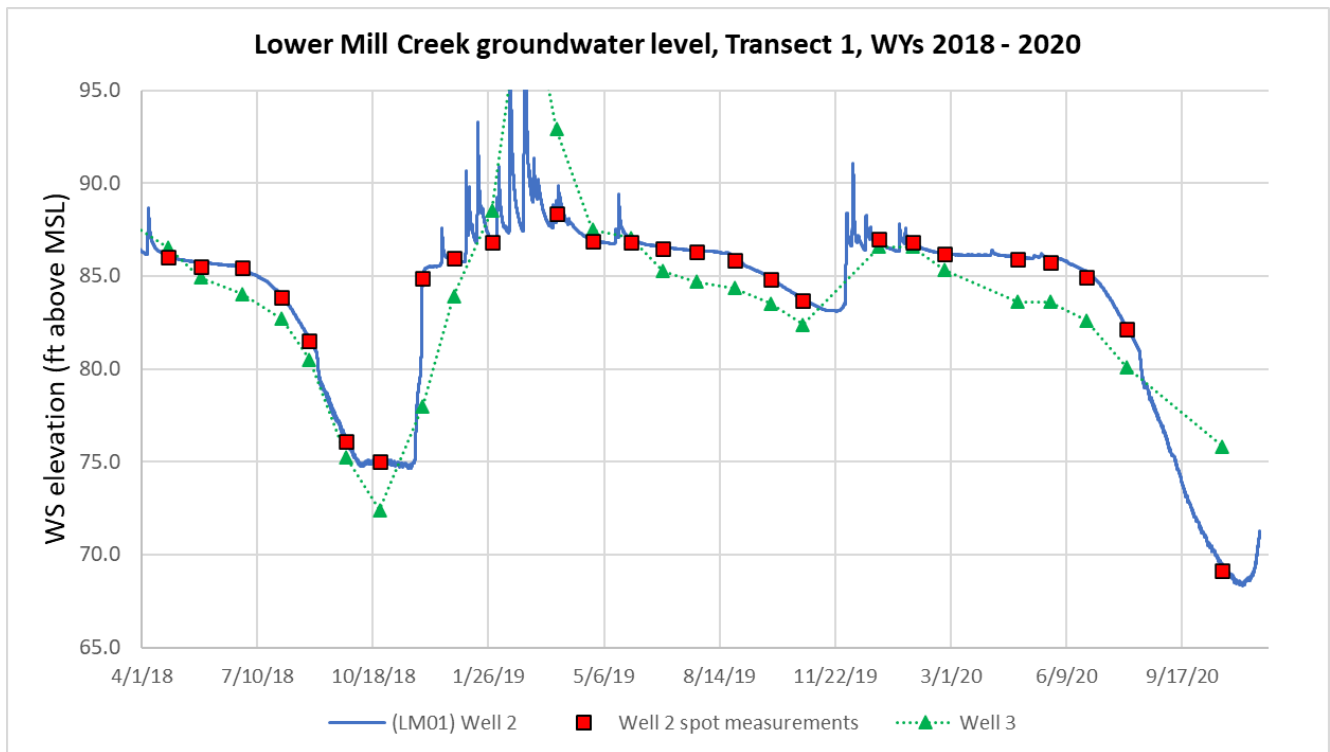
Figure 10. Water surface elevation (ft above MSL), Transect 1, Lower Mill Creek, WY2018 - WY2020.

Transect 1. Transect 1 compares the continuous groundwater gage, LM01, in Well 2 to Well 3 monthly measurements. LM01 is adjacent to the channel, while Well 3 is further out on the floodplain. Figure 10 compares these wells over the course of the 2018 – 2020 study period. Well 3 was observed to have higher levels than Well 2 during the spring of 2018, and during the winter and spring of 2019. It was only during 2020 that the near-channel well lost water to the floodplain well year-round, with the exception of late October.

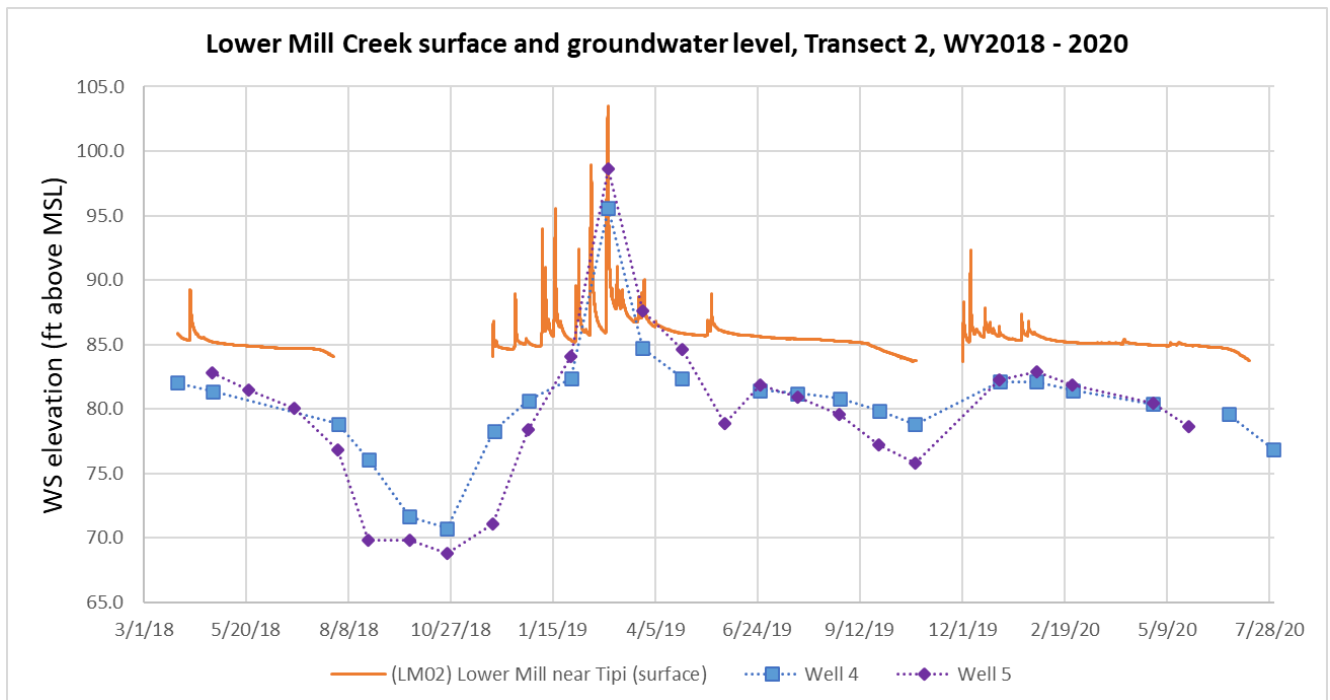
Figure 11. Water surface elevation (ft above MSL), Transect 2, Lower Mill Creek, WY2018 - WY2020.

Transect 2. Transect 2 is comprised of data from the furthest upstream surface water gage (LM02), Well 4, which is close to the gage on the channel bank, and Well 5, which is further out on the floodplain. Figure 11 shows surface and groundwater levels in transect 2 for the duration of the 2018 – 2020 study period. This shows that groundwater levels are consistently lower than surface water levels. In the largest storm of the study, in late February 2019, both groundwater and surface water levels rose considerably, but groundwater was still lower than surface water. The lowest groundwater levels recorded were in the fall of 2018, however, sparse data from fall of 2020 likely misses another deep drop in groundwater levels.

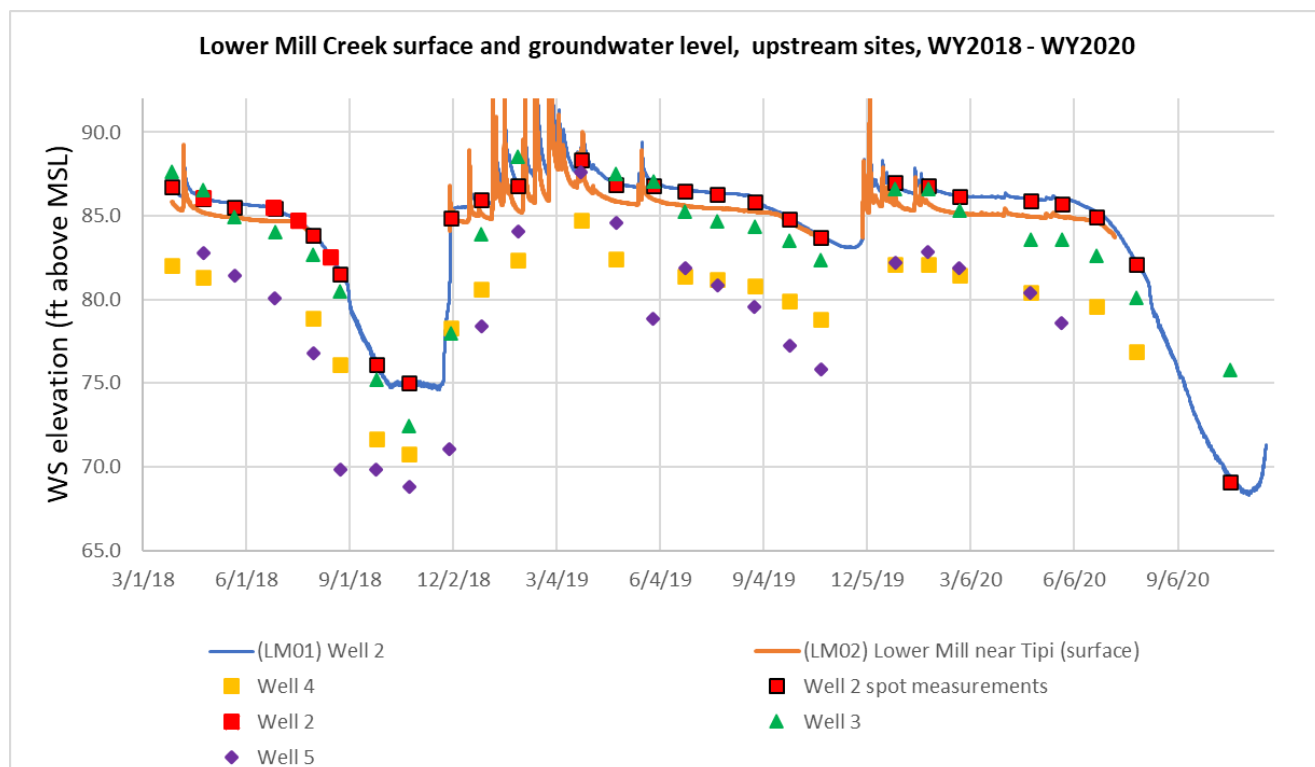
Figure 12. Water surface elevation (ft above MSL), Transects 1 and 2, Lower Mill Creek, WY2018 - WY2020.

Figure 12 shows the data from the upstream sites, Transect 1 and Transect 2, plotted together for the entire study period. This plot shows that through the years, a similar pattern emerges, with groundwater and surface water at Transect 1 remaining within 1-3 feet of each other, but consistent disconnection of about 3-5 feet between surface and groundwater at Transect 2 sites.

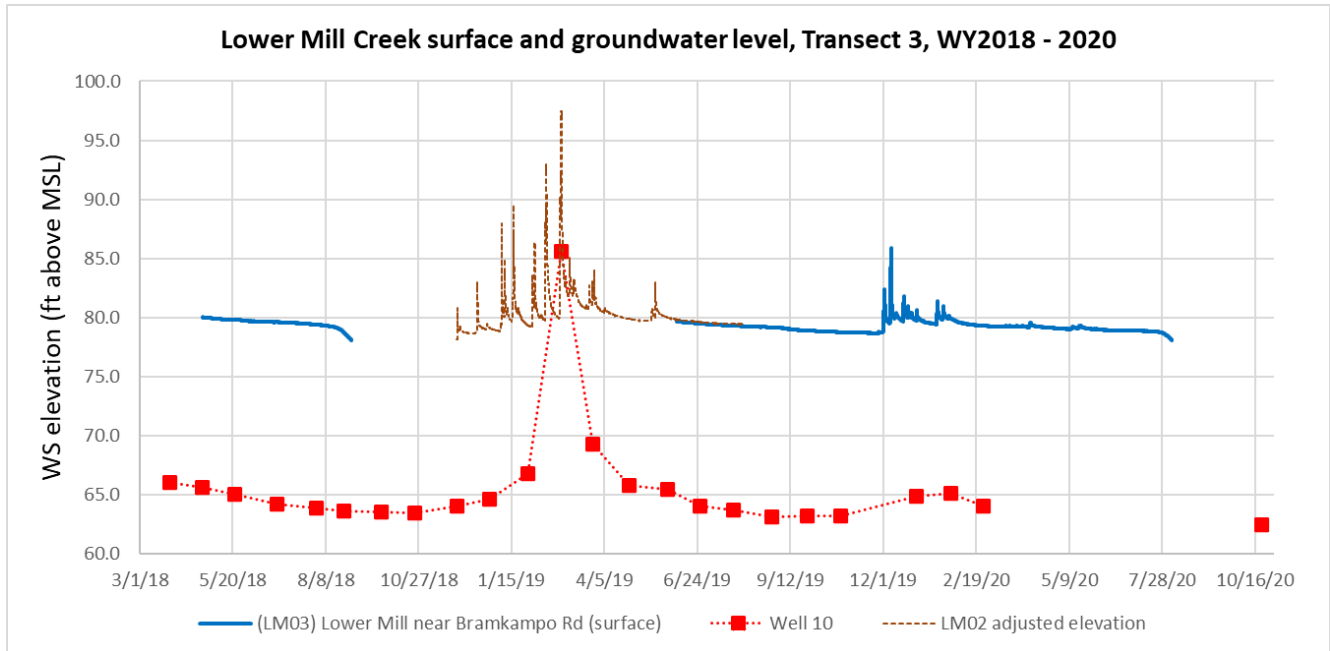
Figure 13. Water surface elevation (ft above MSL), Transect 3, Lower Mill Creek, WY2018 - WY2020.

Transect 3. Figure 13 shows data from Transect 3 throughout the 2018 – 2020 study period, which includes the downstream surface water gage (LM03), and Well 10, which is a floodplain well (see figure 8). Adjusted elevation data from the upstream LM02 gage is shown as reference during a gage gap due to washout. The data show that while the groundwater at Well 10 rose in response to the largest storm of the study (February 2019), groundwater levels are consistently perched about 15 feet below surface water in this reach.

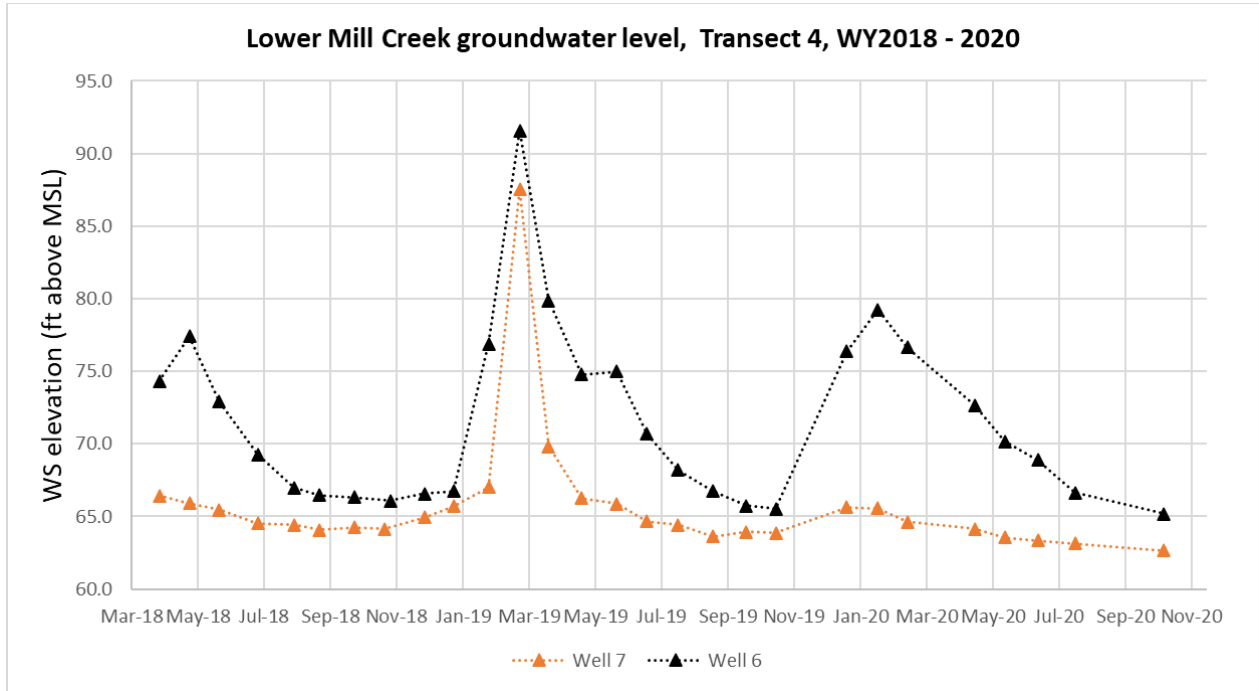
Figure 14. Water surface elevation (ft above MSL), Transect 4, Lower Mill Creek, WY2018 - WY2020.

Transect 4. Figure 14 shows data from Transect 4 throughout the 2018 – 2020 study period, which is comprised of a cross section between two groundwater wells – the near-channel Well 7, and the floodplain Well 6 (see figure 8). At these wells, the water level out on the floodplain was consistently higher than the water level adjacent to the channel. This far down the watershed, it is possible that the floodplain aquifer is under the influence of inputs from Dry Creek.

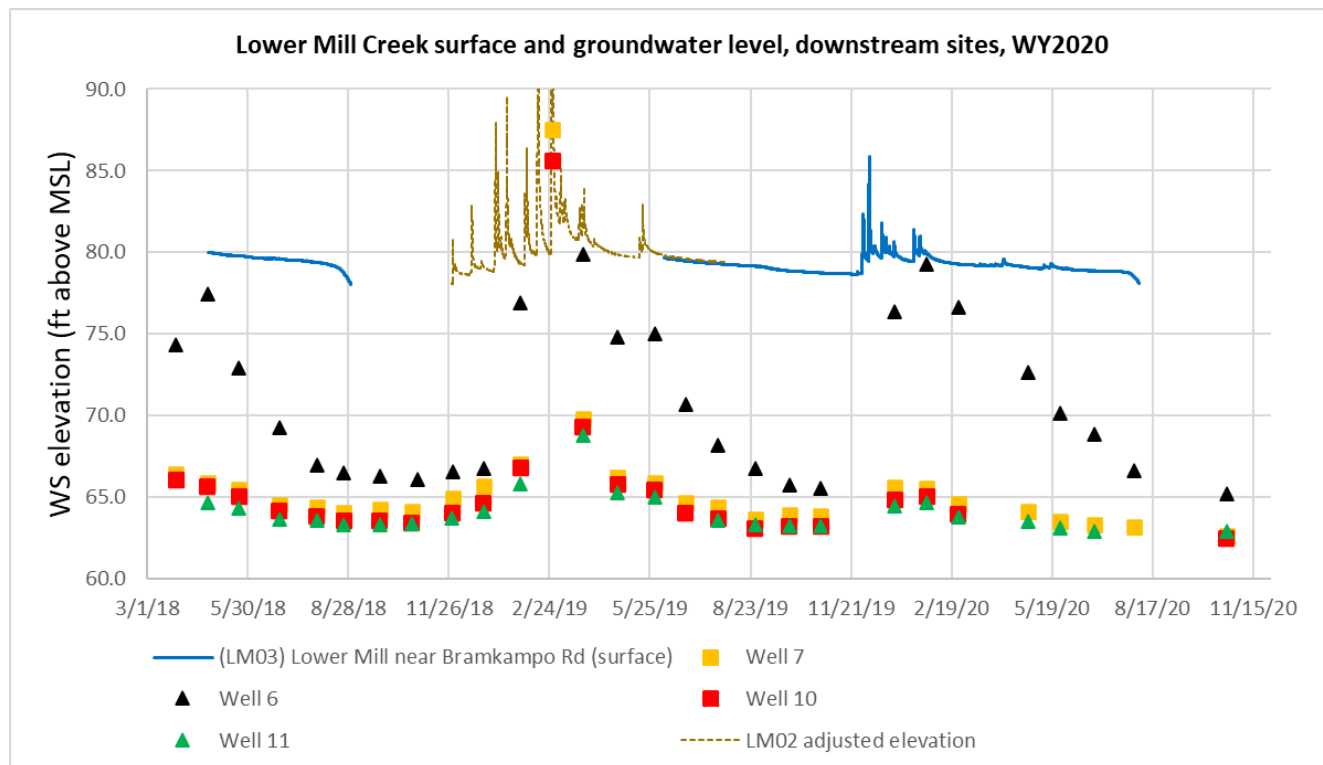
Figure 15. Water surface elevation (ft above MSL), Transects 3 and 4, Lower Mill Creek, WY2018 - WY2020.

Figure 15 shows the data from the upstream sites, Transect 3 and Transect 4, plotted together for the entire study period. These data show that throughout the year, groundwater levels were considerably lower than the level of the surface water. The surface water table is perched approximately 15 feet above the groundwater table at all times. The exception is Well 6, which is likely influenced by Dry Creek. Levels here approach the same level as the surface water during the winter months.

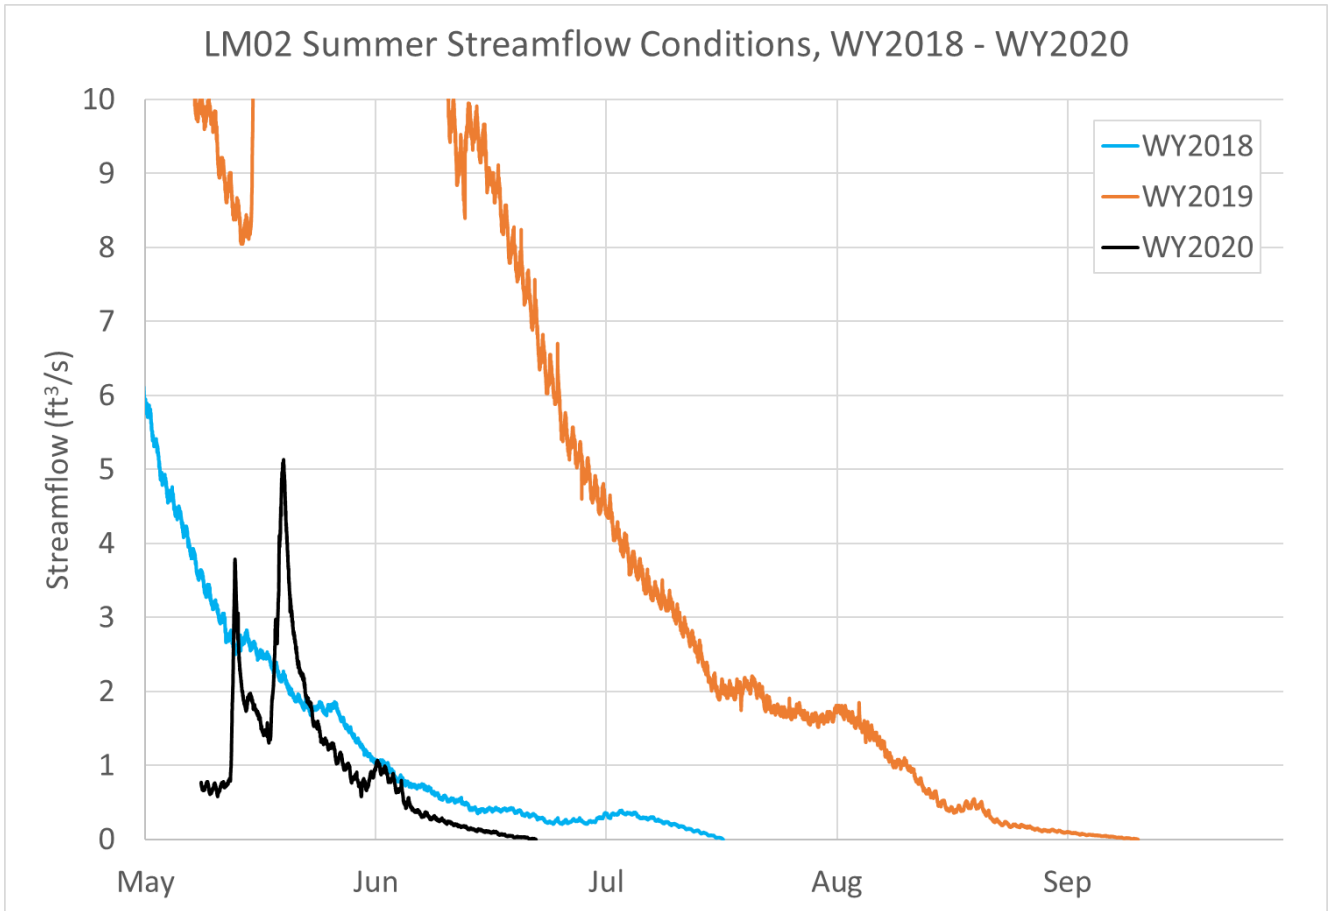
Figure 16. Summer streamflow conditions at LM02 (ft³/sec³), WY2018 – WY2020.

Streamflow monitoring at the surface water gages began in spring each year and continued until the channel dried out. A comparison of streamflow conditions from water year 2108 through water year 2020 is shown in Figures 16 and 17. Low streamflows in 2020 reflect the fact that 2020 was the driest year in our study period. In water year 2018, flows in early May were at about 6 ft³/sec. In water year 2019, the wettest year of the study, flows were above 10 ft³/sec at this time. In early May of 2020, flows at the same sites were about 0.8-1 ft³/sec. Despite some small spring peaks in 2020, flows were generally lower than all other years, and dried out the earliest. Water year 2018, the next driest in our study, had slightly higher flows through the year, and flows persisted about 1-3 weeks longer than in 2020. Despite being a drier than average year, streamflows in 2019 were considerably higher than those observed in both 2018 and 2020. Flows in this year did not disconnect until the fall, and some pools in the lower reaches were wet year-round.

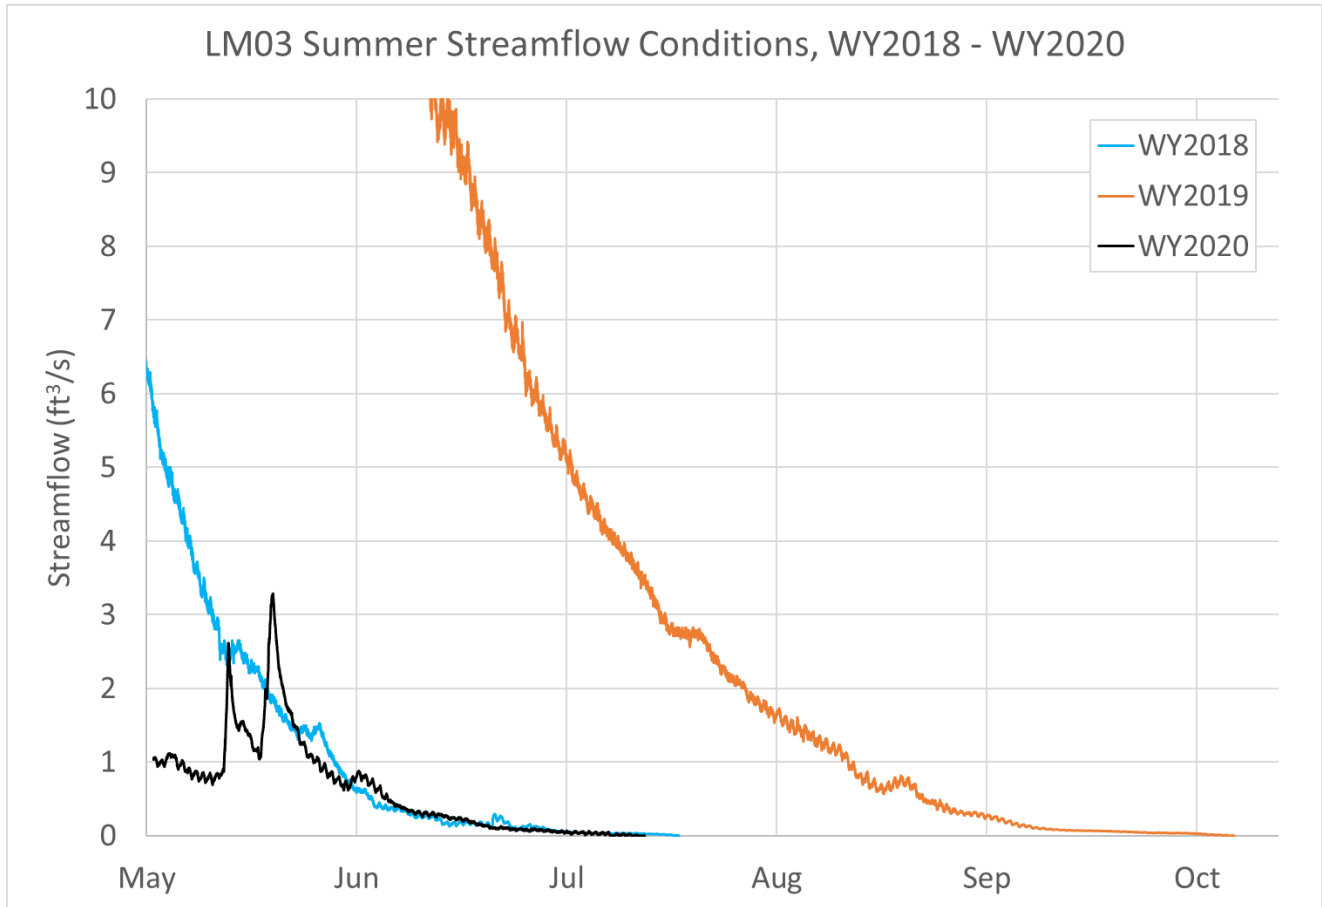
Figure 17. Summer streamflow conditions at LM02 (ft/sec³), WY2018 – WY2020.
